A Geologic Assessment of Historic Saint Elizabeth of Hungary Church Using the Cultural Stone Stability Index, Denver, Colorado

Casey D. Allen*, Stacy Ester**, Kaelin M. Groom[†],
Roderick Schubert**, Carolyn Hagele**, Dana Olof**,
Melissa James**

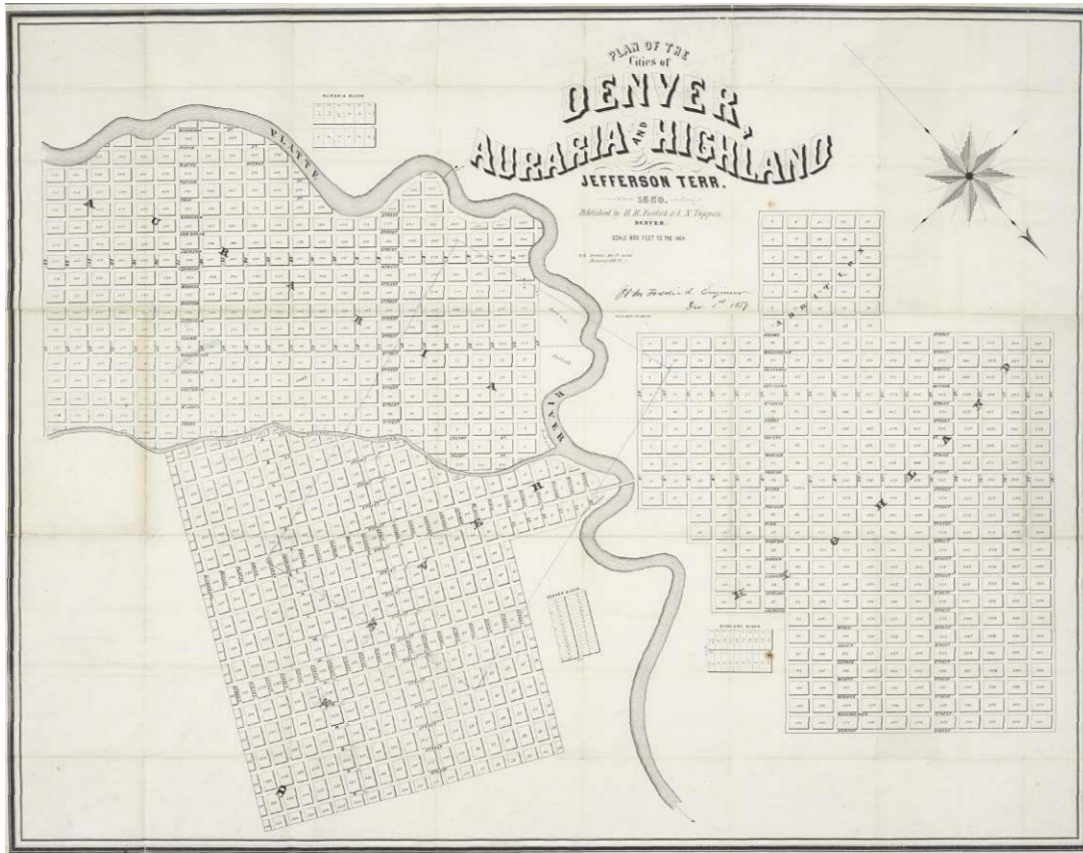
FIGURE 14.1 Map of Denver, Auraria, and the “Highlands” in 1859 by H.M. Fosdick. Highlands is to the right of the (large) Platte River, with Auraria (top-left), and Denver (angled, bottom-left), divided by Cherry Creek, where gold was first discovered in Colorado. Source: Denver Public Library.

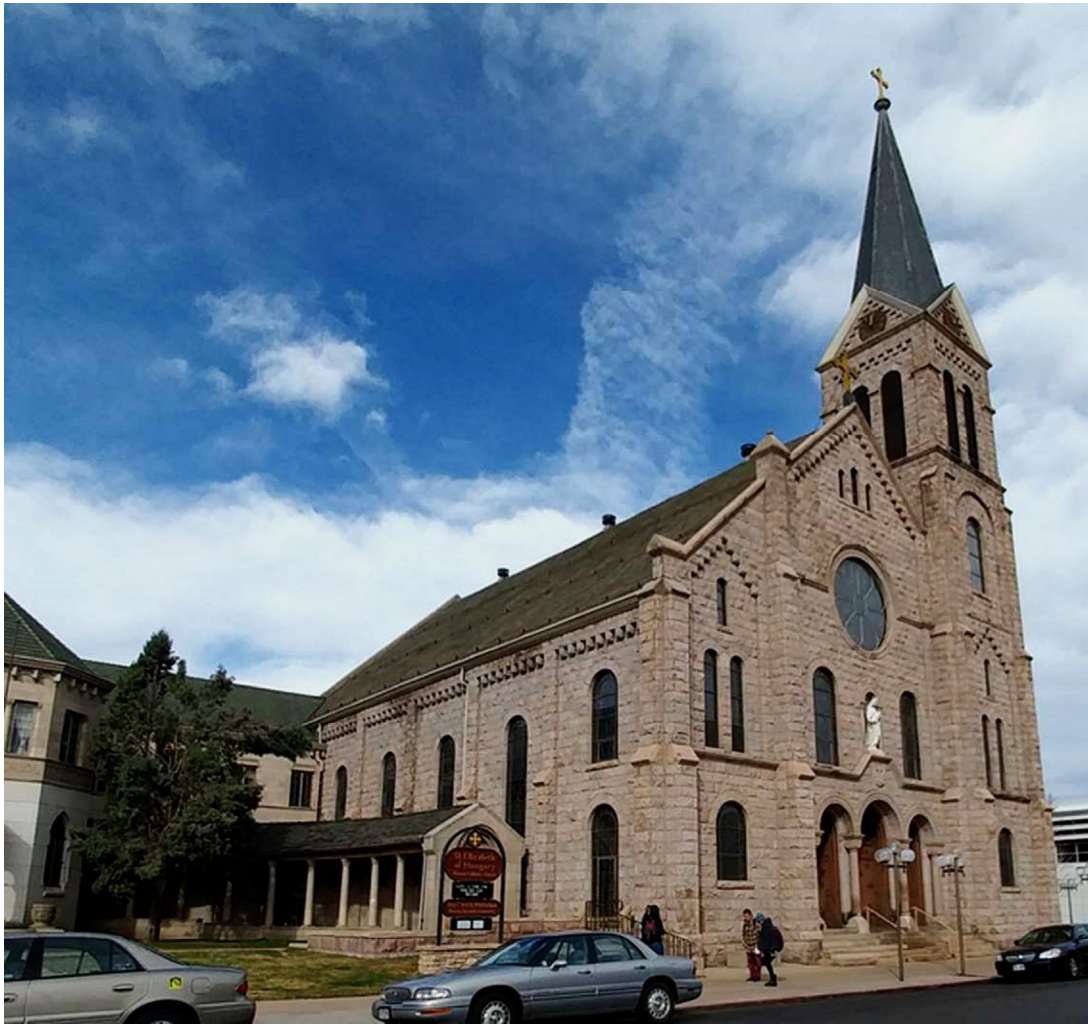
FIGURE 14.2 Saint Elizabeth of Hungary Roman Catholic Church as viewed from the southeast corner (looking northwest) showing the church's south-facing side and front entryway (east-facing, with the white statue, center). While the overall building is structurally sound, decay processes are occurring on all four sides.

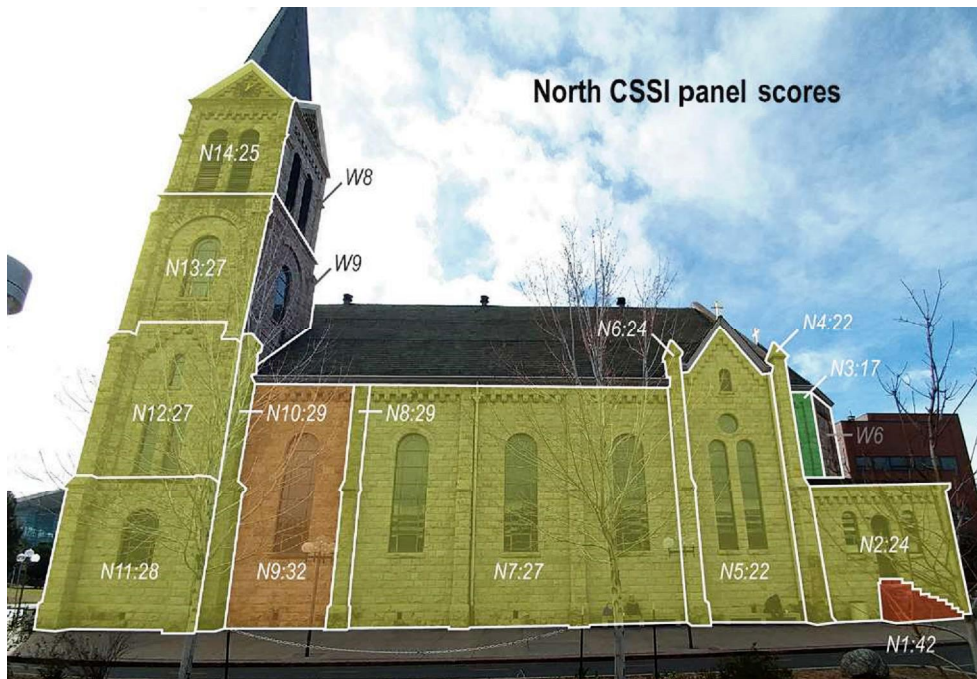
FIGURE 14.3 The north-facing facade of Saint Elizabeth. Most of the aspects retain “Good condition” (yellow color) as measured by the CSSI, but several panels exhibit specific decay processes that have already occurred or will occur in the near future, especially N1 and N9.

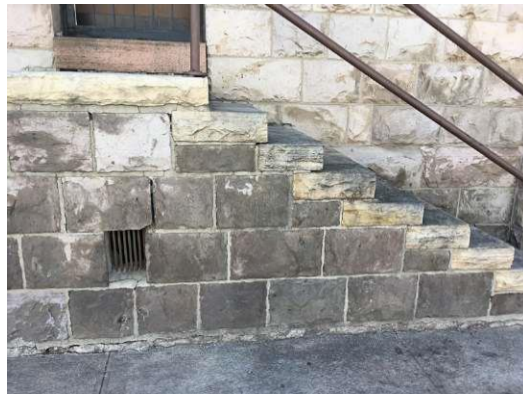
FIGURE 14.4 Panel N1, covered with a heavy (anthropogenic) coating. Notice also the missing mortarwork above the vent, creating a gaping fissure as well as other multiple cracks in the mortar.

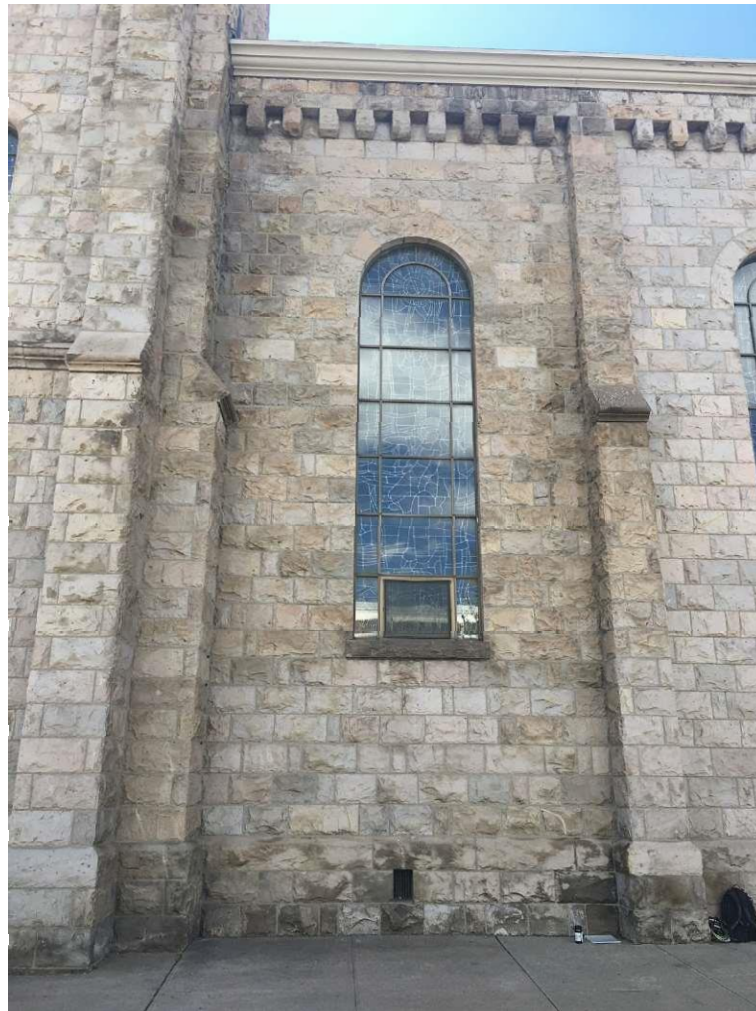
FIGURE 14.5 Not cleaned like its neighboring panels, N9 hosts a much darker color (rock coating). Most rock coatings enhance stability (Dorn, 1998) and removing them improperly can be detrimental to the host stone, opening the door for fiercer decay processes.

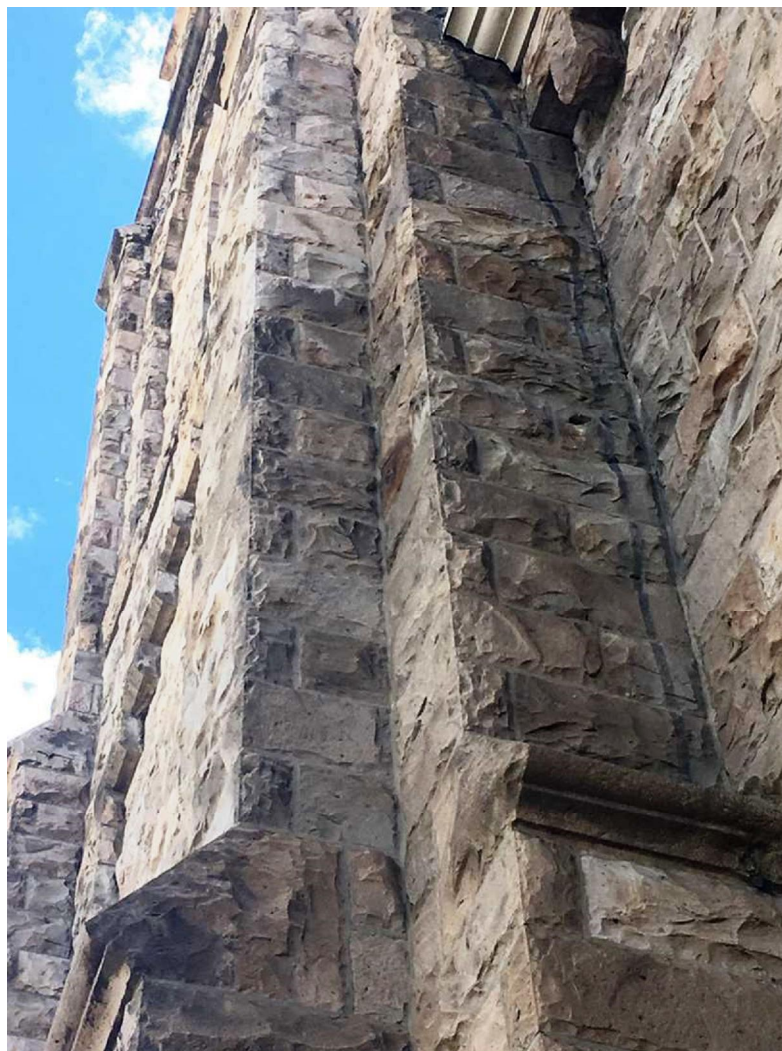
FIGURE 14.6 Dark-color vertical stripes on the side of N10, perhaps from old piping. Notice the difference in coloration between the portion of N10 that hosts the stripes and that to its immediate left. The left-side portion of N10 has been recently cleaned.

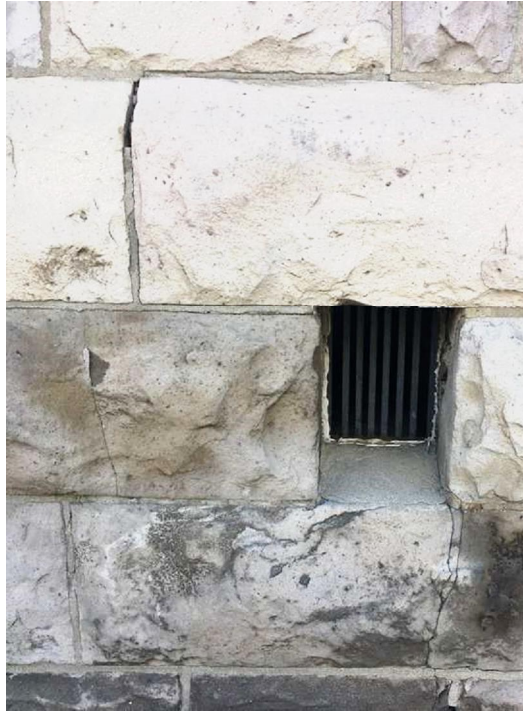
FIGURE 14.7 An example of fissures around air vents. In this example from N11, fissures around the vent are visible. Note also the scaling event—a small chunk of rock missing in the middle of a fissure independent of lithification on the stone to the left of the vent's grate.

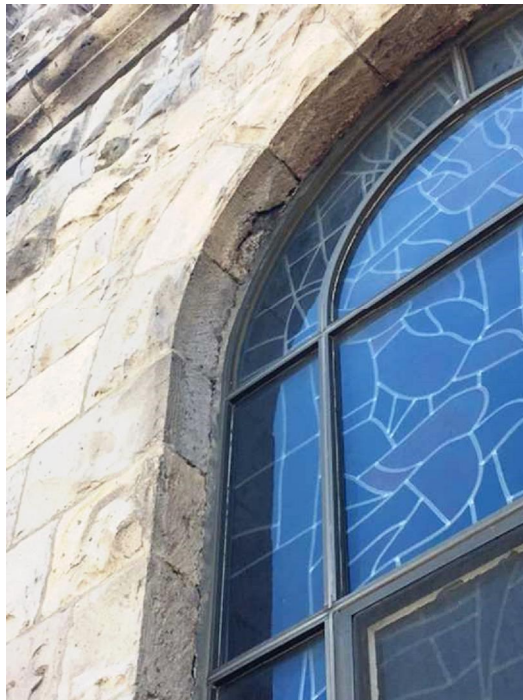
FIGURE 14.8 Flaking events already occurred and impending around N11's arched window. Similar forms were also observed on the upper windows of N12 and N13.

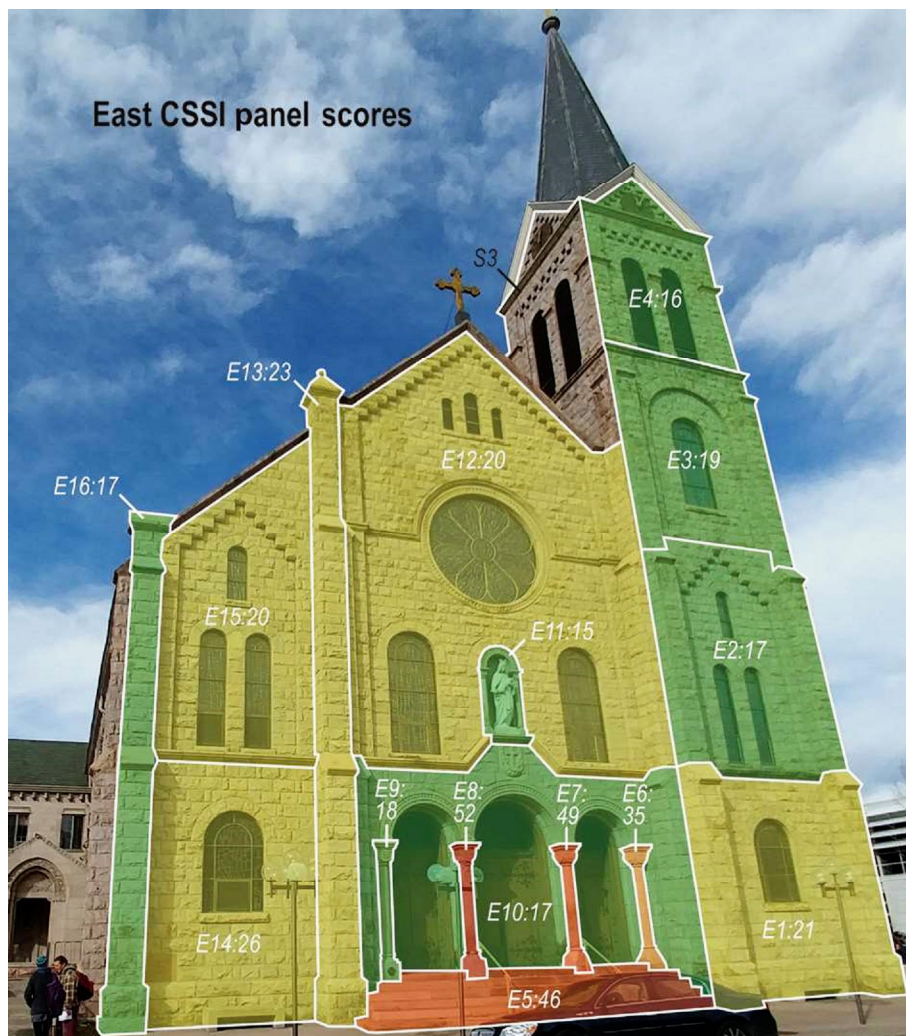
FIGURE 14.9 Saint Elizabeth's east-facing facade. Earning an overall score of 25 ("Good condition" status), the east facade has some looming problems that, if not addressed promptly, may result in large stone loss and the need for very costly repairs. In particular, E5, E7, and E8 remain at high risk, especially E7 and E8—the highest scoring panels on the entire structure and in "Urgent danger of erosion," specifically, at their bases (compare with Figs 14.13–14.16).

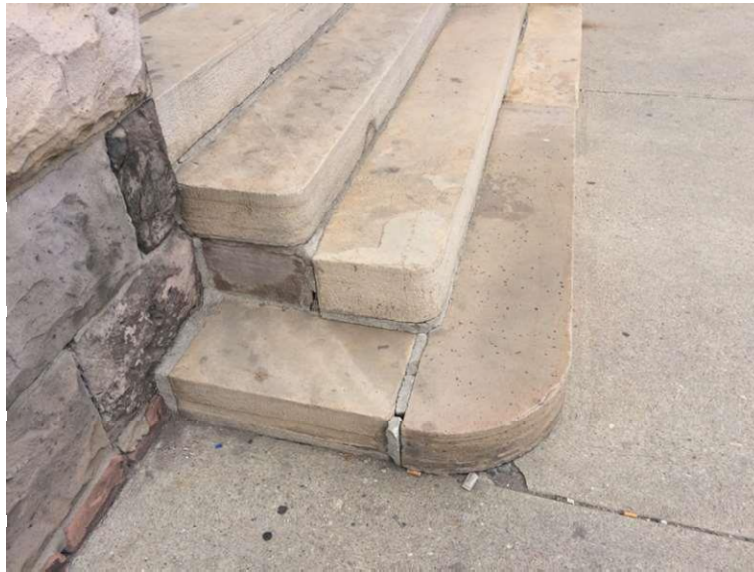
FIGURE 14.10 The stairs of Saint Elizabeth’s main entryway on the east-facing facade. As Saint Elizabeth is still a functioning church, it is no surprise that these stairs remain in “Urgent danger of erosion.” Specifically, notice the impending splintering of individual stairs and loose/cracked mortar, similar to N1 (compare [Figs 14.4 and 14.5](#)).

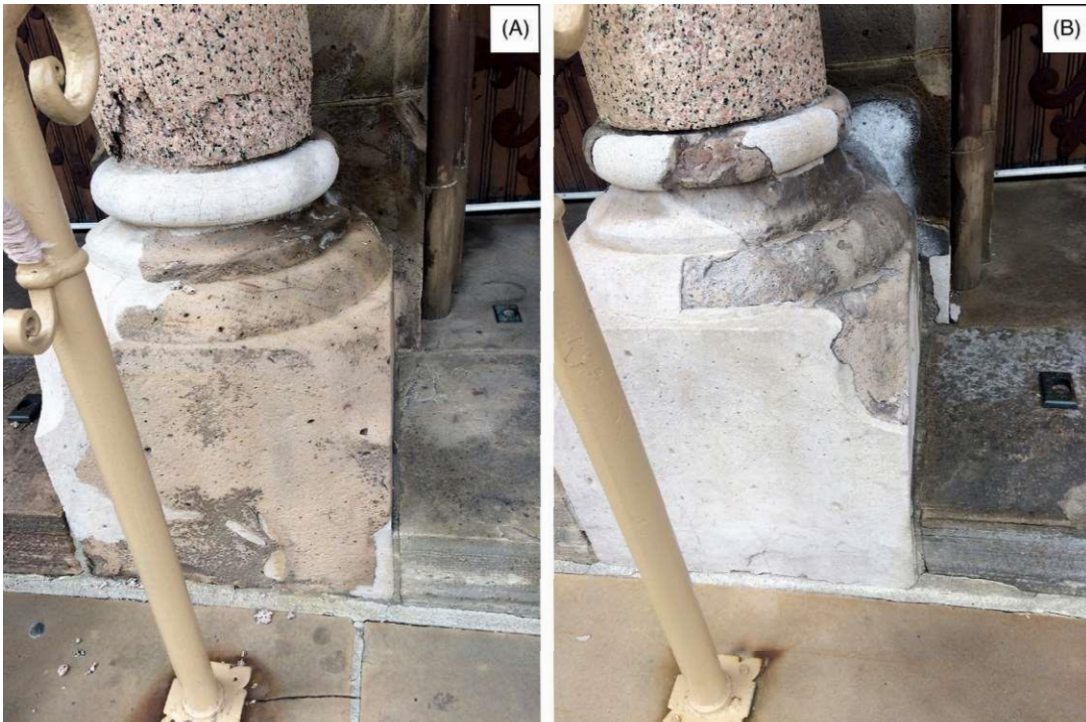
Small future scaling (spalling) on the base of E9 (a column) was also observed; and the main entrance hosts many fissures at each base ([Fig. 14.12](#)). This is a high-traffic area with continual use of the stairs, and stair-railing installation sites also seem to be contributing to

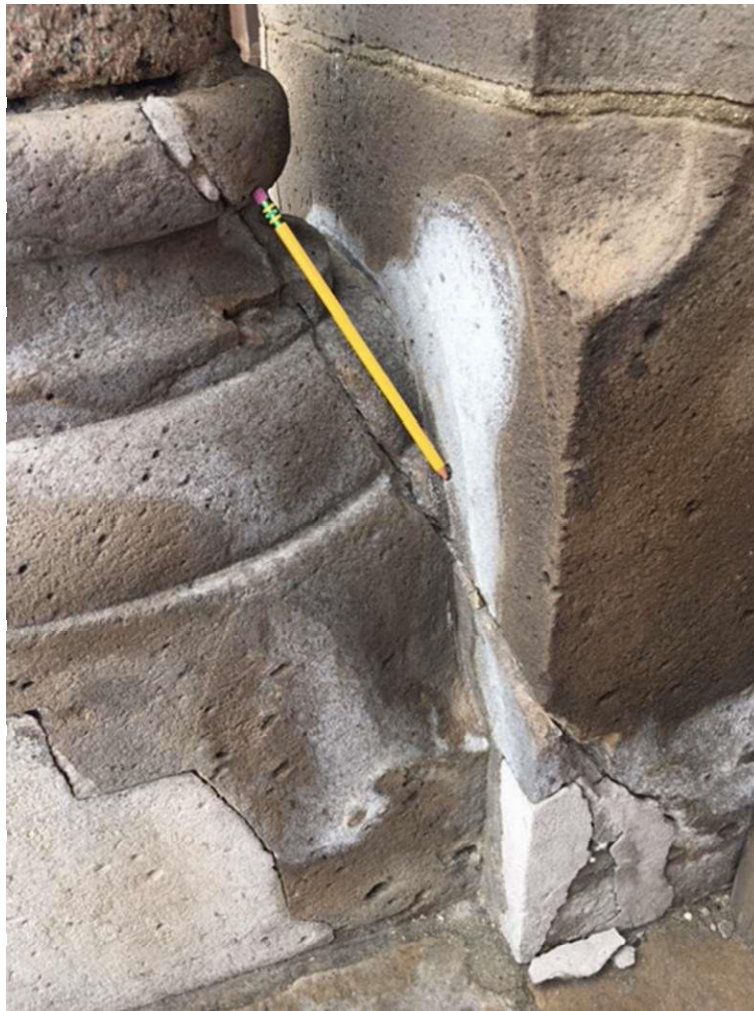
FIGURE 14.12 An example of fissures independent of stone lithification around column bases. This particular fissure (with a pencil for scale) occurs on E8. Just to the right of the pencil is a very light discoloration (*the white areas*) where salt efflorescence and subflorescence is occurring. Often occurring through capillary action, efflorescence, and subflorescence exert pressure on pore spaces, exacerbating interior vulnerabilities of the rock.

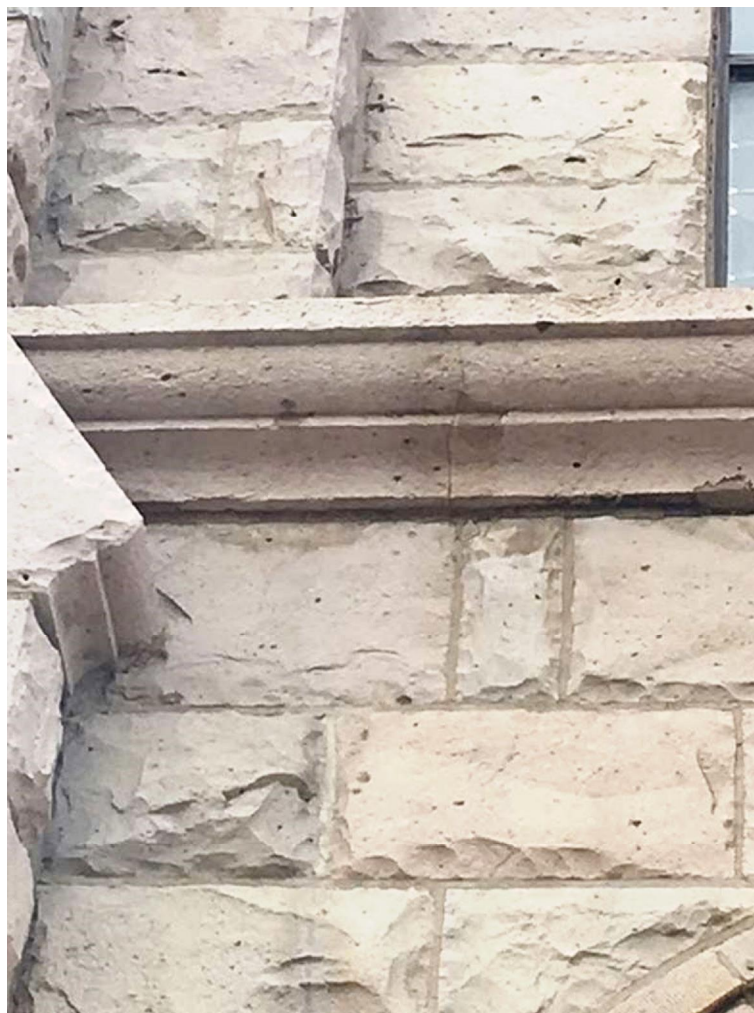
FIGURE 14.13 Fissure independent of lithification extending through a ledge on E10. Left untreated, this fissure will only widen, leading to (small) flaking and subsequent scaling. This ledge also exhibits flaking (right-center and far-right-center).

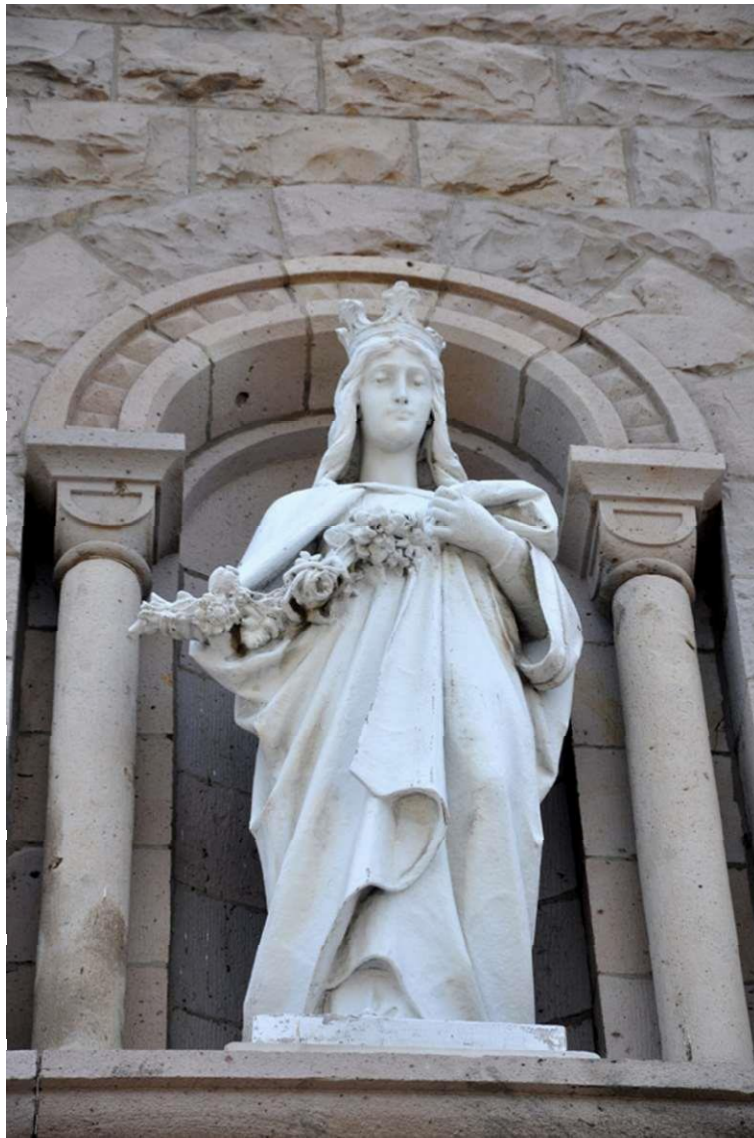
FIGURE 14.14 The statue of Saint Elizabeth adorning the alcove above the church's main entrance. This statue, now over 100 years old, is made of what appears to be concrete (no reference could be found of any records on its creation, even after questioning church personnel, other than its relative age), and is regularly painted to keep its brilliant white color. A close examination via telephoto lens reveals paint chipping off the sculpture, especially around its base. Notice also the missing crown prong.

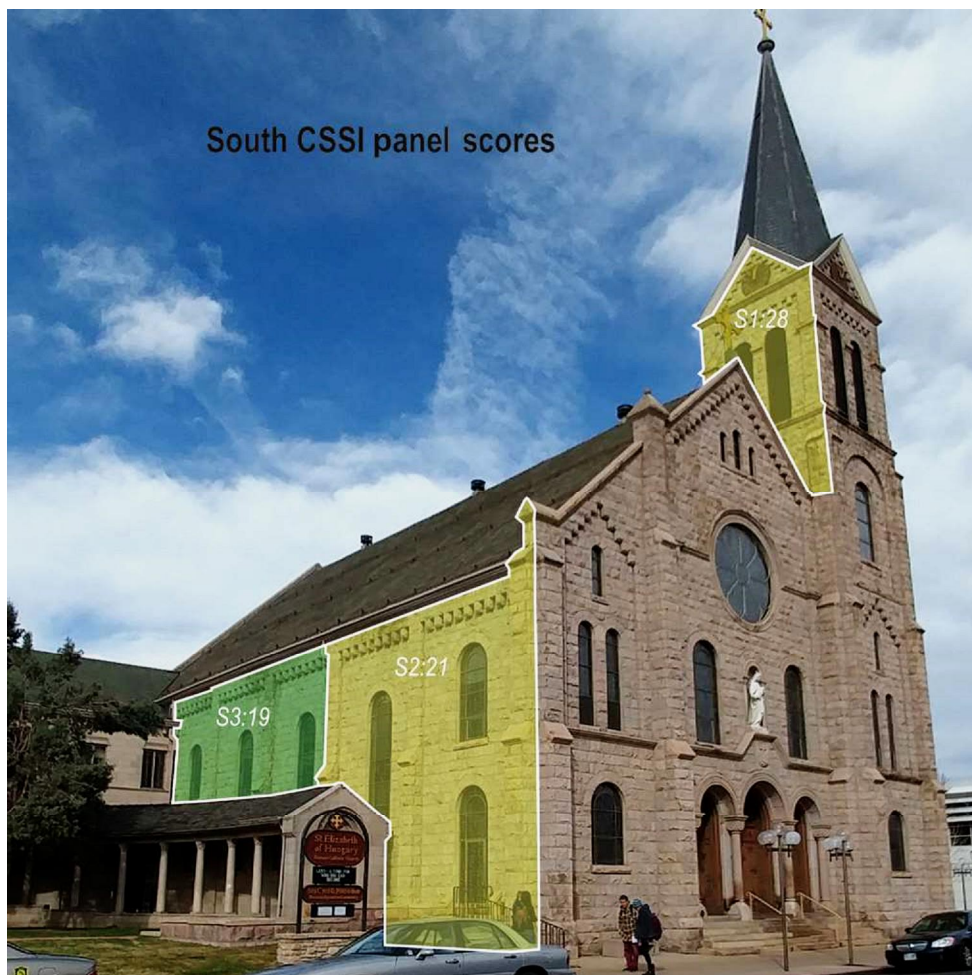
FIGURE 14.15 Saint Elizabeth's south-facing facade, displaying "Excellent" and "Good" CSSI scores. While very stable overall, the church's south aspect did have a few minor concerns, such as fissures, flaking on the underside of window arches, and very small plant growth at the facade's base.

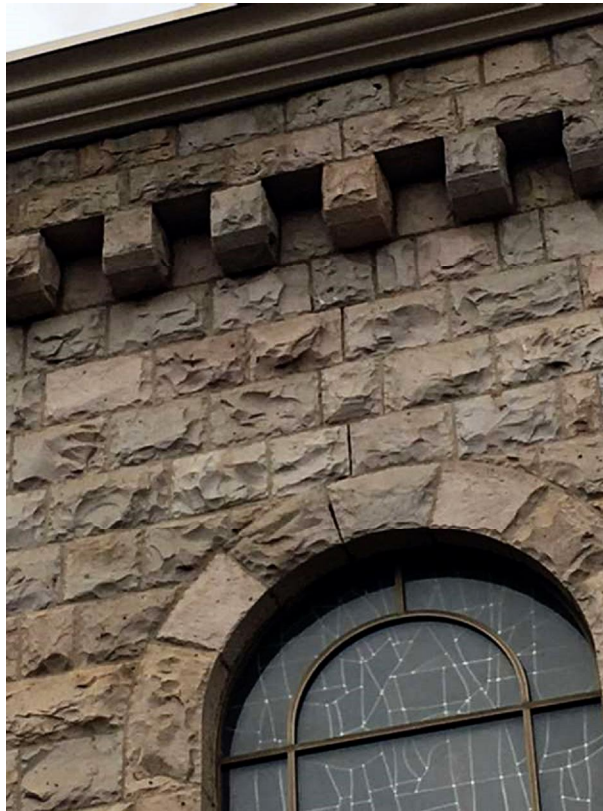
FIGURE 14.16 Beginning at the top of S2's highest window and extending across four bricks, missing mortar creates a gap in the masonry. The open space increases the probability of fissure formation and its resultant flaking and scaling events. This area remains perhaps the most at-risk section of S1.

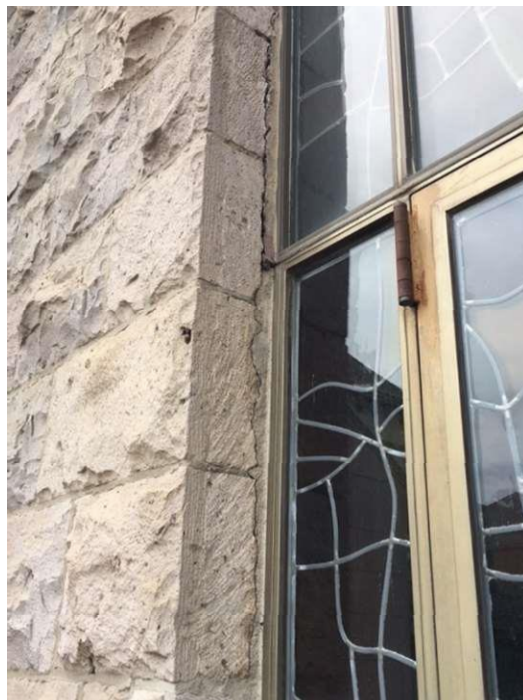
FIGURE 14.17 Creating similar conditions as seen on the underside of other window arches (compare Figs 14.10 and 14.17), the missing mortar along S1's window edge will ultimately lead to flaking and scaling events if left untreated. Specifically, note the large crack between the stone of the arch and the windowpane, extending from the old mortar work (bottom-center) all the way to the beginning of the curve of the archway.

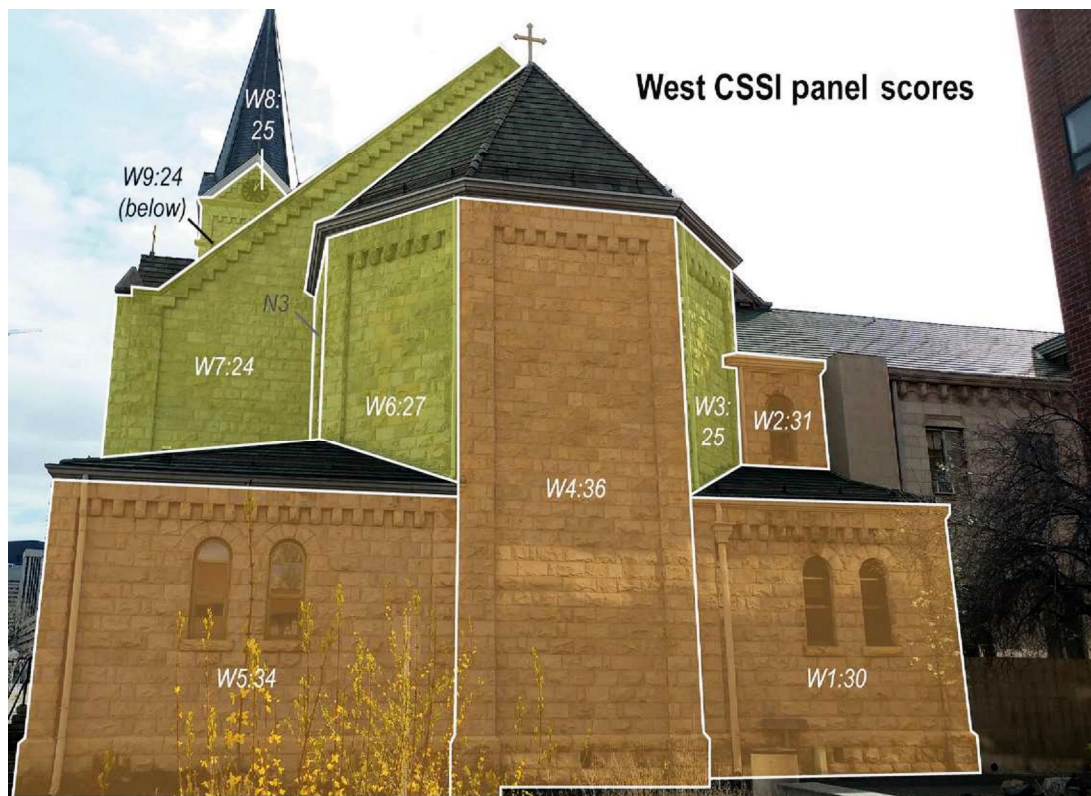
FIGURE 14.18 Saint Elizabeth's west facade. Although the west aspect earned the highest average CSSI score (28), panels with aspects offset slightly to the north or south did not display as high a ranking as those facing directly west, revealing that aspect may play a role in stone decay processes (Groom, 2014).

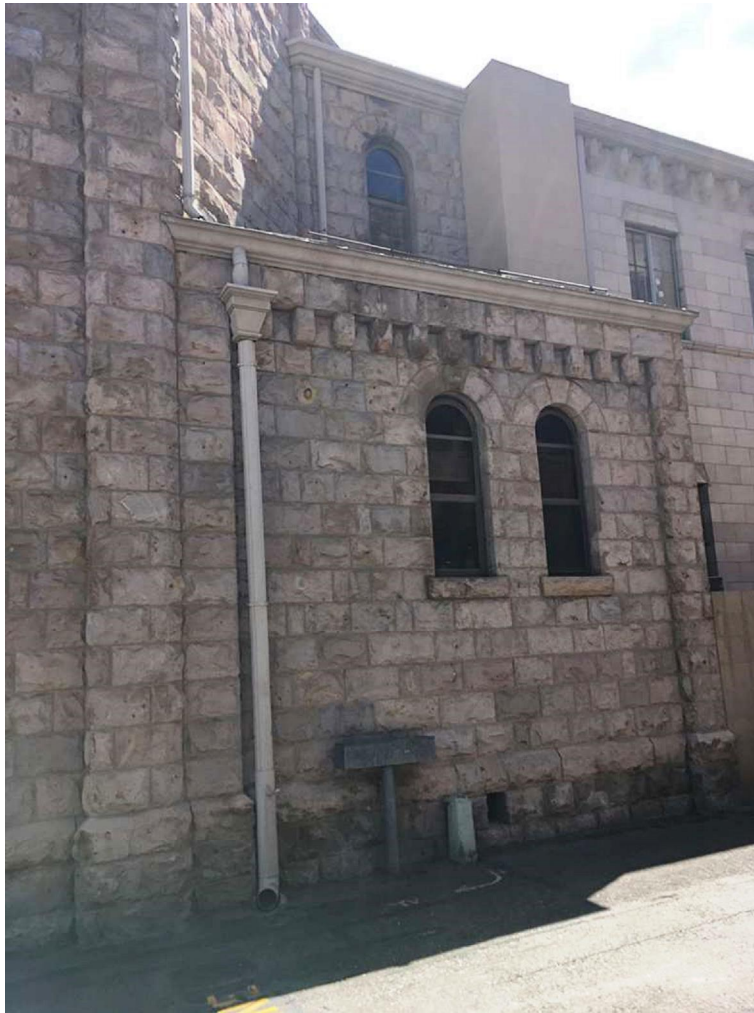
FIGURE 14.19 Panels W1 (two windows), W2 (singular window, above W1), part of W3 (to the left of W2), and W4 (left of drainpipe). This image shows the thick, dark, and continually present anthropogenic coating of Saint Elizabeth’s west facade. The coating extends the aspect’s entire length and about 1 m above ground level.
