## CHAPTER SIX: CASE STUDY #3

### From Rock Art to Edifices:

*A Preliminary Adaptation of Pre-existing Field Techniques to Assess*

*Cultural Stone Stability in Petra, Jordan*

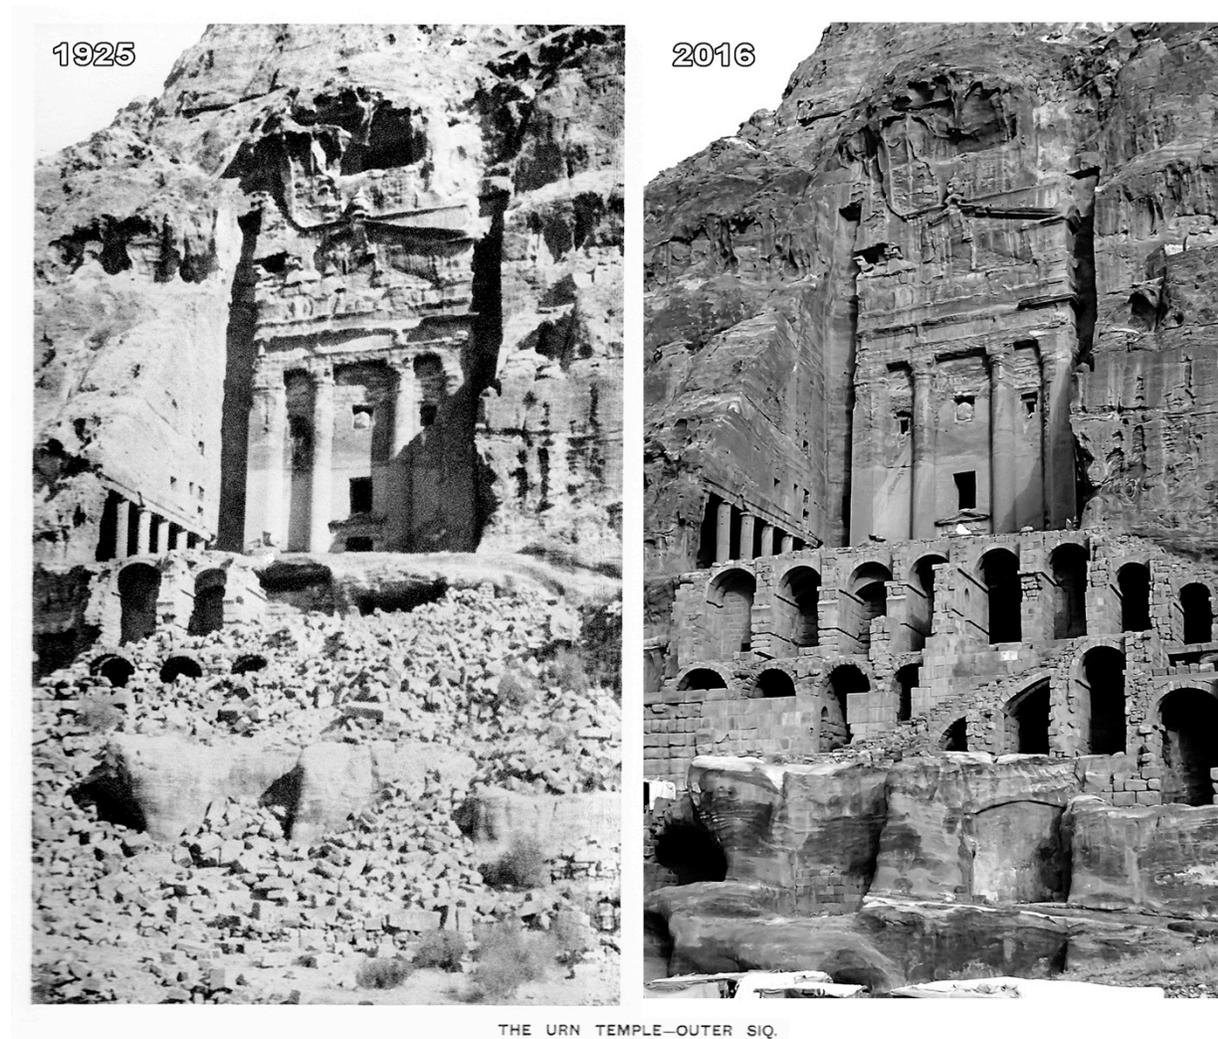
landscape. Monument reconstruction and restoration with modern building materials are just a few examples of this influence (Fig 6.4).

*Figure 6.4: Repeat photographs of the Urn Tomb, one of the Royal Tombs. The reconstruction of the stairs and arches with modern materials are among the most notable changes. 1925 photograph from A. B. W. Kennedy (1925). 2016 photograph by author.*

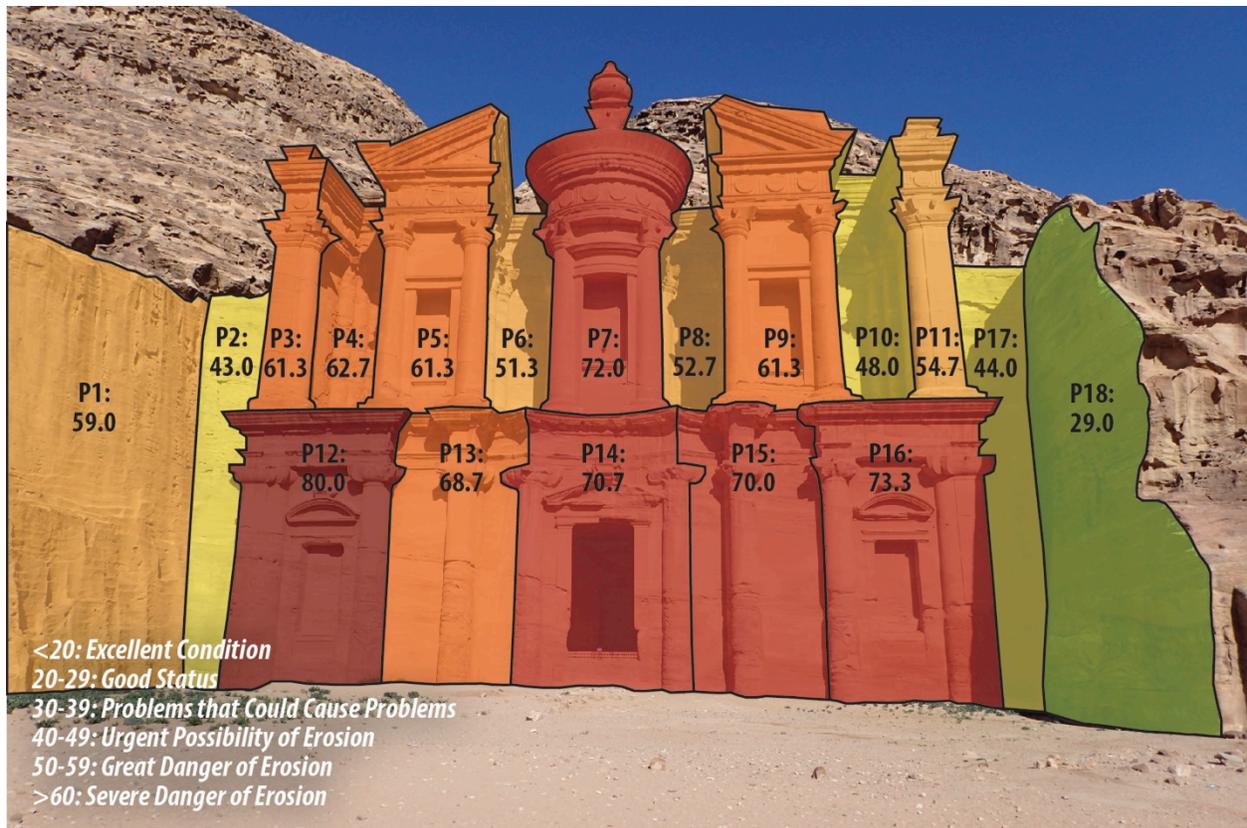
With an average CSSI site score of 59.09, the Deir rests precariously between the second highest and highest descriptive categories for RASI/CSSI—*Great Danger of Erosion* and *Severe Danger of Erosion*, respectively—indicating significant issues with this massive monument (Figure 6.5). Seemingly stable when viewed from a distance, the grandeur of this façade serves to mask the myriad of decay processes negatively impacting the stone. In fact, binoculars were required to assess the upper levels, since the size of the monument limited access and viewing necessary to accurately identify decay features, many of which were indistinguishable with the naked eye from the ground. Upon closer inspection through binoculars, the Deir’s many stability concerns are much more apparent.

These issues are reflected in the site’s CSSI scores, with stone texture and corresponding factors causing the most concern. Incorporated in nearly every category of RASI/CSSI, texture is a physical characteristic of stone reflecting intrinsic lithological features, such as clast/matrix ratios, and can influence decay. For example, Paradise (1995) discovered several thresholds where sandstone matrix compositions, closely related to texture, strongly influenced decay rates. Arguably, rougher textures, manifestations of stone porosity characteristics, may suggest the stone is either more susceptible to or

Figure 6.5: The different CSSI panels and scores for the Deir. Colors coordinate with degree of degradation, ranging from green indicating stable conditions to yellow, to orange, to light red, to dark red signifying the highest CSSI scores and most significant decay. Graphic and photograph by author, 2016.

already experiencing decay processes that involve a deterioration of the matrices responsible for holding clasts together, such as flaking (both preparing and detached), granular disintegration, and scaling (McKinley & Warke, 2007; Prikryl & Smith, 2007)—all of which regularly scored high at the Deir. Changes or discrepancies in texture can also affect decay, such as iron banding creating impermeable layers within the stone stopping the movement of water, salts, and dissolved minerals between substrates. This can cause a build up of usually mobile elements, effectively localizing decay along specific textural boundaries (Warke et al., 2006). This is the case for the Deir, as bountiful iron concretions and leisegang banding throughout the monument have channeled decay along specific strata.

Textural anomalies have also created a spatial pattern of decay for the Deir, with the lower levels experiencing relatively higher rates of decay than the upper levels. Decay features commonly associated with salt accumulation, such as flaking and granular disintegration, ranked higher along the ground level

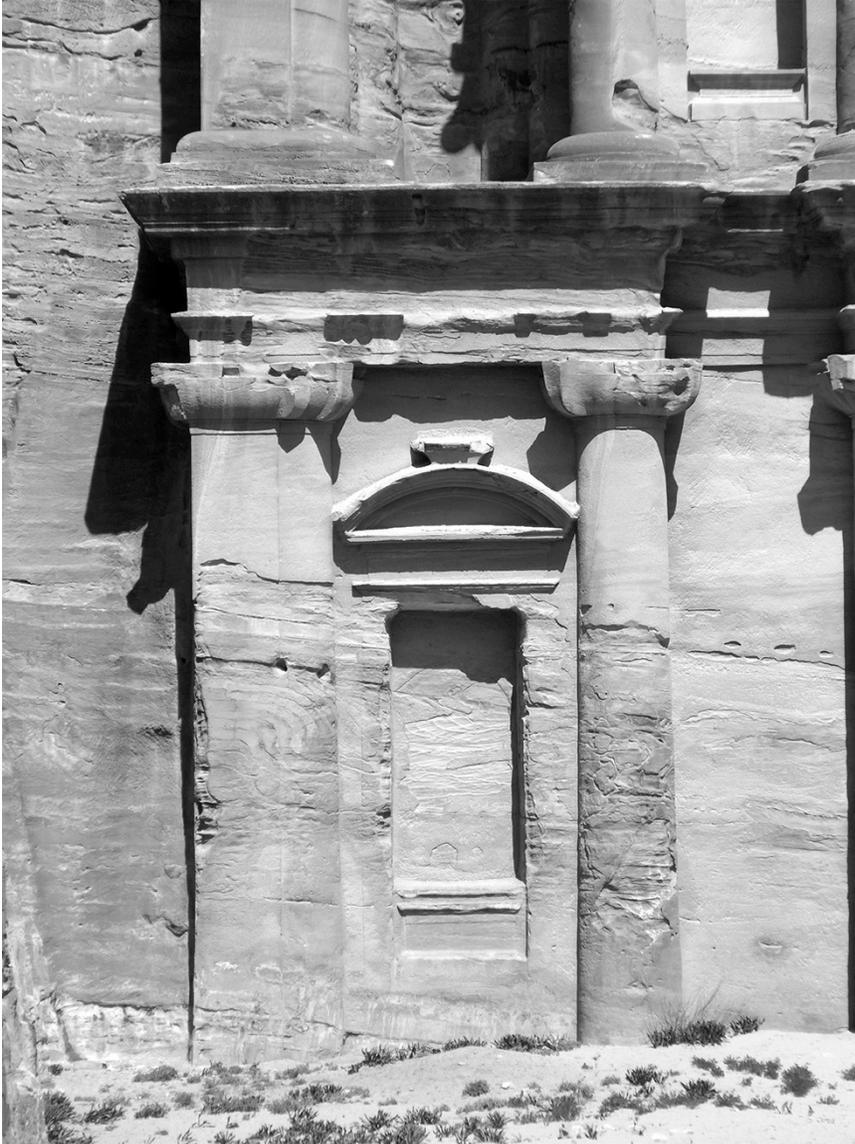
*Figure 6.6: Closer photograph of the textural anomalies on the Deir Panel 12. Much of the horizontal striations and red coloration are exposed areas of the host sandstone where the stone dressing has deteriorated. The green patches are small bushes (roughly 0.5 meters diameter) for scale reference. Some graffiti and vandalism can be found on the lower sections of both columns. Photograph by author, 2016.*

panels than the upper story panels with noticeably different surface textures between levels. This is most likely due to a large iron band dissecting the lower level of the monument, creating a distinctive stopping point for wicking salts and minerals migrating up the stone. The highest scoring panel at the site, panel 12: 80.0, contains the largest section of exposed sandstone below this boundary, exhibiting the immense damage that can be caused by concentrated salts and other expansive minerals (Figure 6.6).

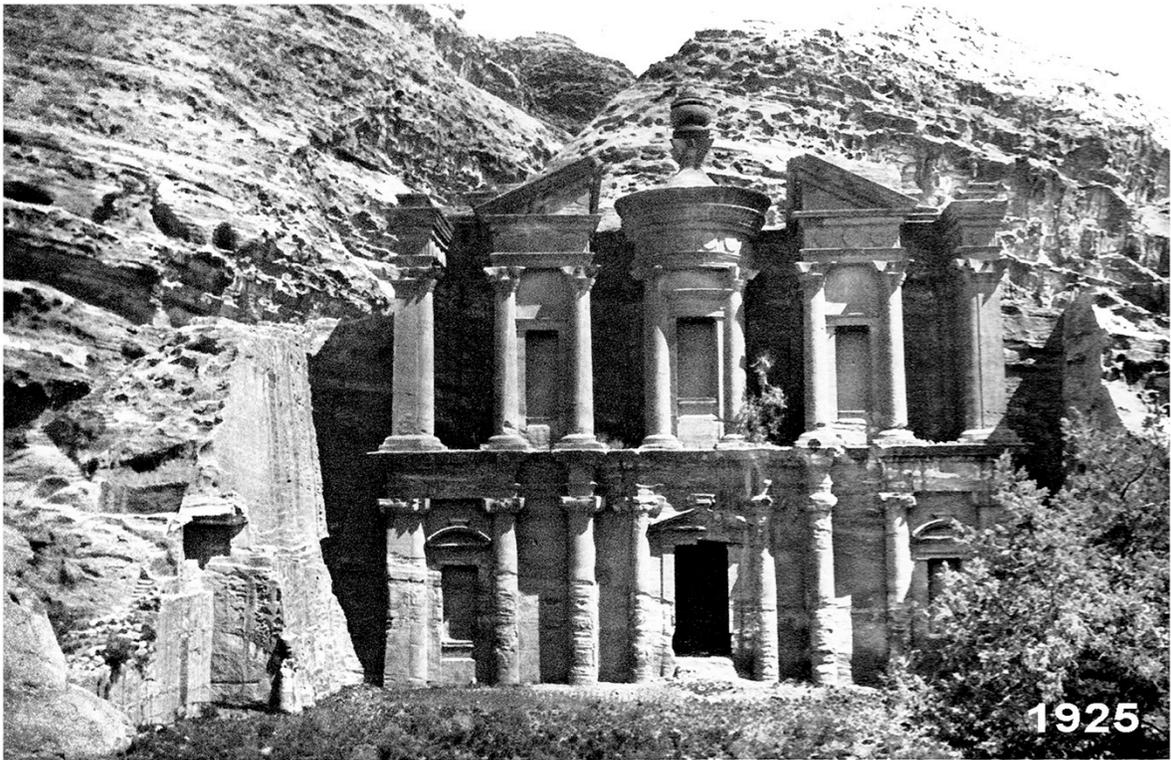
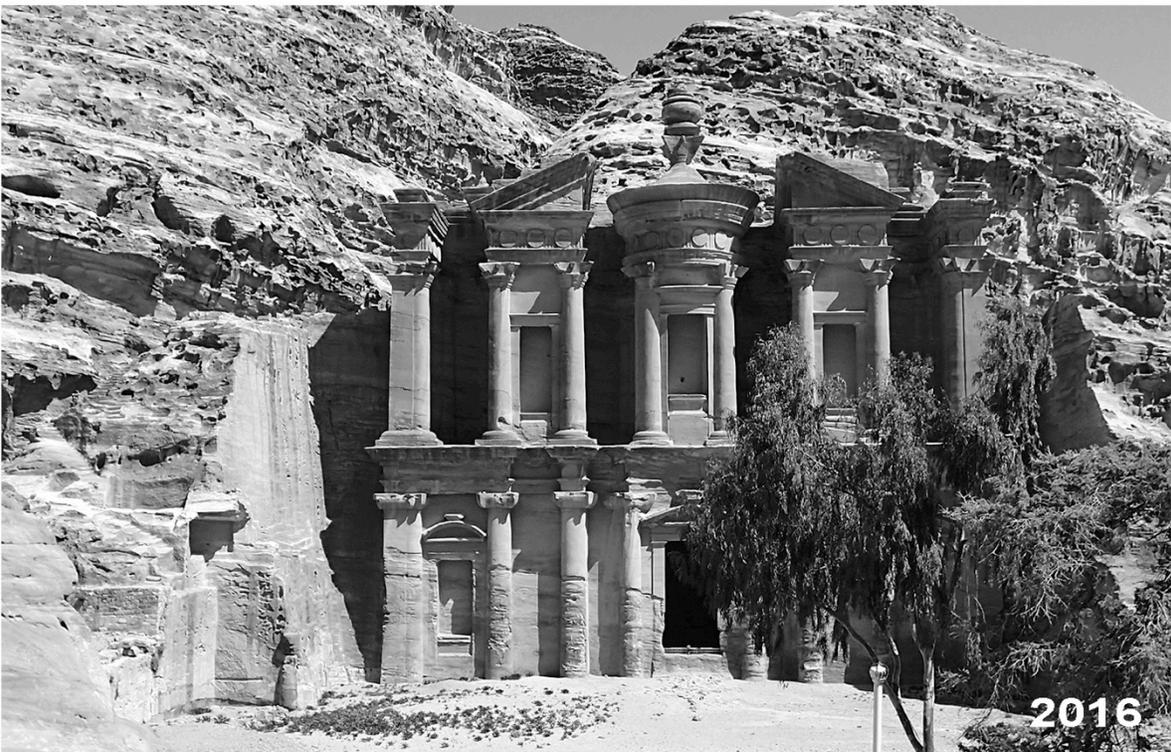
Providing a more aesthetical assessment of the Deir's contextual setting and physical condition, the repeat photography analysis identified a few major landscape changes over the past century that could influence the monuments stability moving into the future (Figure 6.7). The most obvious change has been vegetative. The shrub growing on the upper façade has been removed and the thick vegetation growing around the base of monument has been reduced to scattered grasses. The ground change in ground cover could be due to a number of factors including grazing, increased foot traffic, climate change, or intentional removal to enhance visual appeal or access to the site. Another explanation for the vegetation loss may be minimal excavation of the hewn niche in the left hand side of the image, as evident by a lower ground levels in the area and newly exposed soil lines and horizontal fissure in the recent repeat. In addition, the trees growing to the right of both pictures, subsequently obscuring part of the façade, are different species, indicating the previous tree either died or was removed and the current tree has grown in its absence.

In terms of the monument itself, the repeat pair illustrates the deceptively intact appearance of the monument by revealing relatively little discernable difference over the past century. Major decay concerns identified in the CSSI analyses appear to have been influencing the monument long before modern tourism was established in the valley. The large textural band influencing CSSI scores on the lower levels of the monument is clearly visible in the historic image, along with the advanced decay in the areas below it. The most significant structural difference between the photographs is the large hole in the center upper window. Closer inspection revealed what appear to be several bullet holes around the intentionally removed material, indicating vandalism as the cause for the discrepancy (Figure 6.8).

Unfortunately, vandalism and unsafe behavior is an on-going problem in Petra and at the Deir, forcing authorities to erect fences, signs, and walls denying access to fragile and potentially dangerous areas. The newly established guardrail preventing people from entering the inner chamber of the Deir is clearly visible along the base of the entrance, as well as the various signs informing visitors that going

Figure 6.7: Repeat photographs of the Deir (The Monastery). 1925 photograph from A. B. W. Kennedy (1925). 2016 photograph by author.

beyond the rail is forbidden. In addition, visible in the lower left corner of the images is a small, reconstructed rock wall blocking a questionable footpath leading up the monument's colossal ornamental urn. The path, as well as another trail leading behind the monument, was sealed after a tourist reportedly fell to his death from the top, though no reliable references could be found to confirm this. Despite these heightened restrictions, the Deir is still one of Petra's most famous attractions and local business owners have established a small café and seated viewing area just beyond the scope of the repeated photographs, though the exhaust pipe from the café is visible in the lower right side of the modern repeat.

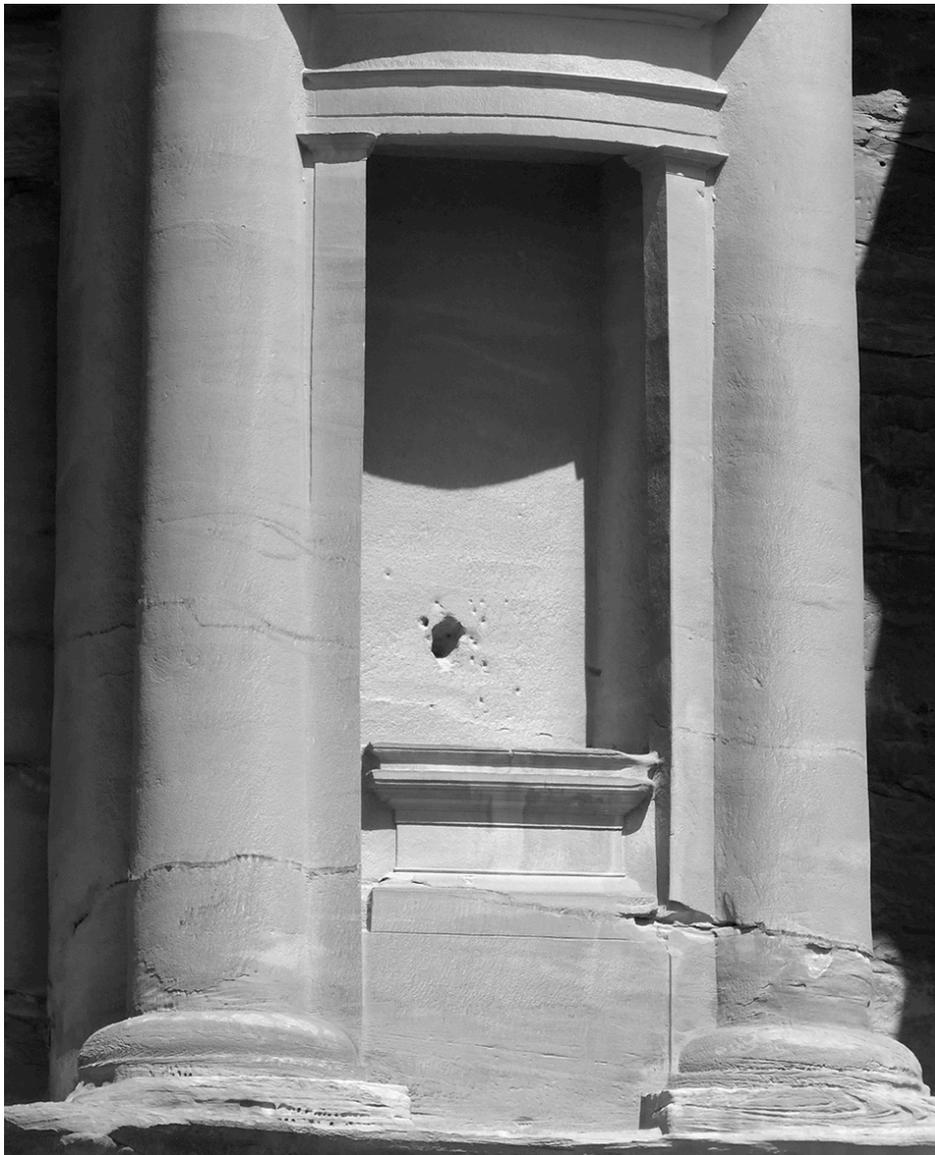
*Figure 6.8: Closer view of the bullet holes and damage within the highest false window, or niche, of the Deir. This inset is in the center panel of the second floor, directly beneath the monument's iconic cone spire and urn decoration. Photograph by Casey Allen, 2016.*

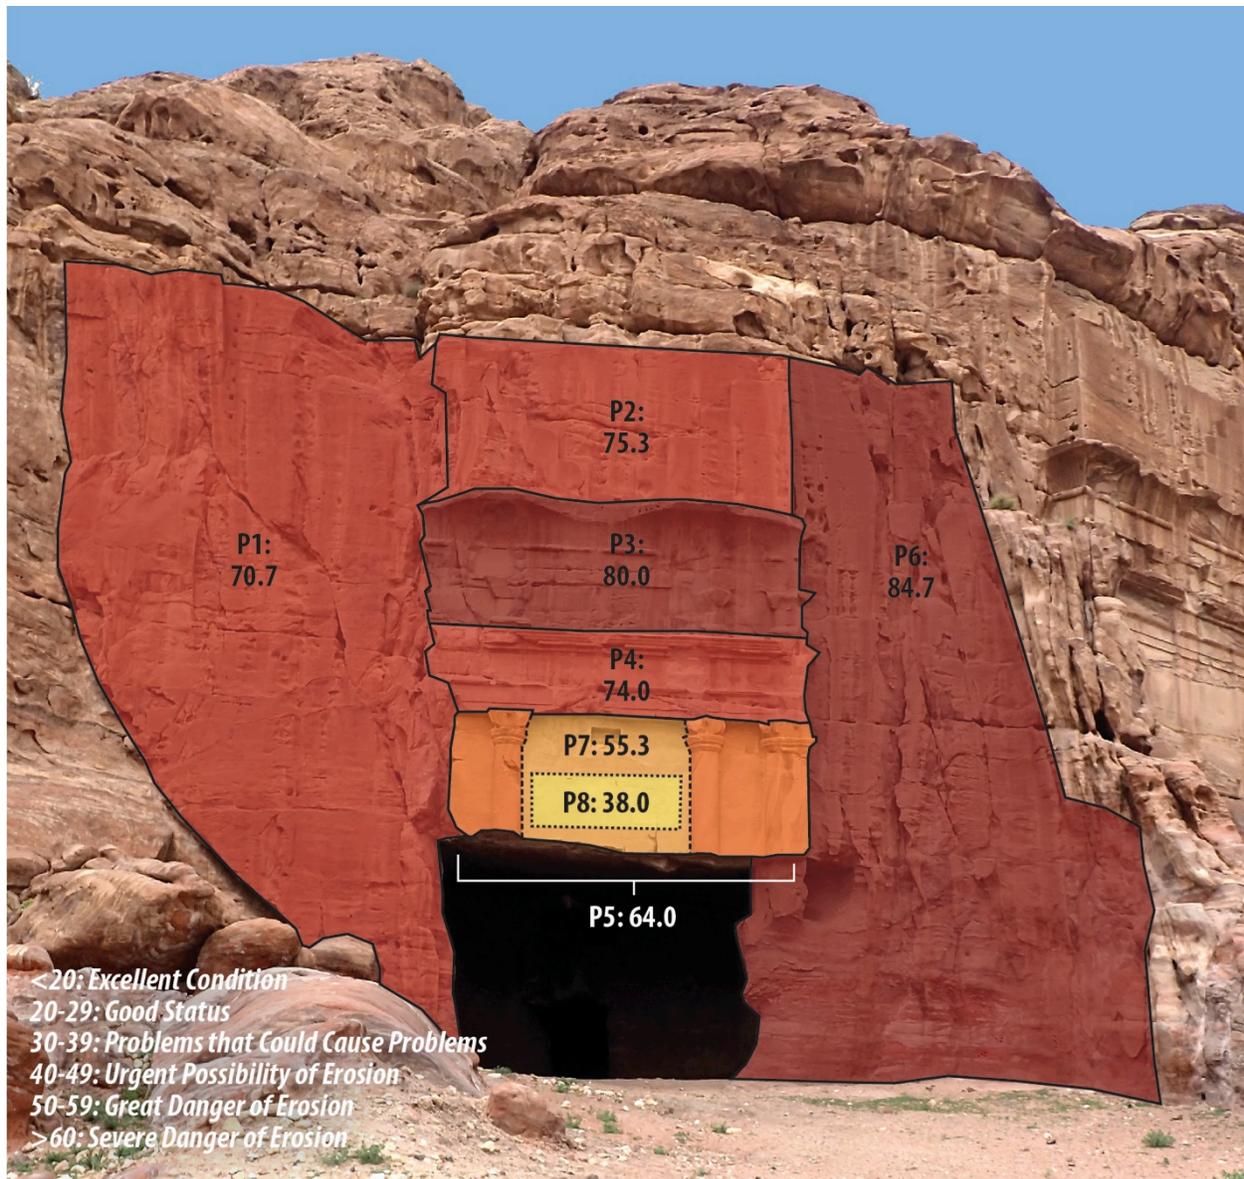
The most damaged of the three assessed monuments, the Turkmanyia Tomb had an average CSSI score of 67.8, well within the highest descriptive category: *Severe Danger of Erosion* (Figure 6.9). Nearly every panel scored between mid sixties to mid eighties—dangerously high for RASI/CSSI scores. The only two exceptions, panels 7 and 8 scoring 55.3 and 38.0, respectively, were supplemental panels designated to assess specific elements within broader panels/features. That said, the general panel on which they are located, panel 5, scored 64.0, which is considered *Severe Danger of Erosion*.

Experiencing most of the rock decay processes typical for sandstone, the CSSI scores for this monument identified major concerns in nearly every section of RASI/CSSI, but the most immediate issues appear to be structural. There are several fissures transecting the façade and the surrounding cliffs, some even spouting springs or vegetation. One large fissure runs vertically through the entire monument and well into the hollowed out interior as well. The disjointedness of the cliff-face makes the tomb vulnerable to undercutting and detachment of large boulders (Wolters & Müller, 2008). In fact, the majority of the monument's lower façade is completely missing, presumably due to rock fall and undercutting. These concerns are reflected in the CSSI scores, as both fissures (independent *and* dependent of lithification) and undercutting (both preparing and detached) consistently scoring high at this site. In addition, some of the smaller fissures have begun to infill with dust and sand, making fissure development, where physical and chemical interactions between accumulated soils exacerbate fissure expansion (Villa et al., 1995), a possible threat to the façade in the near future—though they do not appear to be an immediate problem (only scoring 1s and 2s in CSSI).

While broader structural concerns were the most intense, smaller topical decay is also greatly impacting the visual integrity of the Turkmanyia. Aesthetical elements, such as rounding of the carved features and loss of design details, regularly warranted higher scores. Disaggregation decay processes, such as granular disintegration, crumbly disintegration, and abrasion (all scoring high in CSSI), are prominent across the façade and have effectively reduced large portions of the monument to indistinguishable ledges or pediments with the appearance of having melted. Across the entire monument, there is only one small section on panel 5 that still displays intact original stone dressing

Figure 6.9: The different CSSI panels and scores for the Turkmanyia Tomb. In pretty rough condition, the colors for this tomb begin at yellow (instead of green), to orange, to light red, to dark red signifying the highest CSSI scores and most significant areas of decay. Graphic and photograph by author, 2016.

applied after construction. Other superficial decay processes such as scaling and flaking are also concerns for this site, reflected in their high CSSI scores.

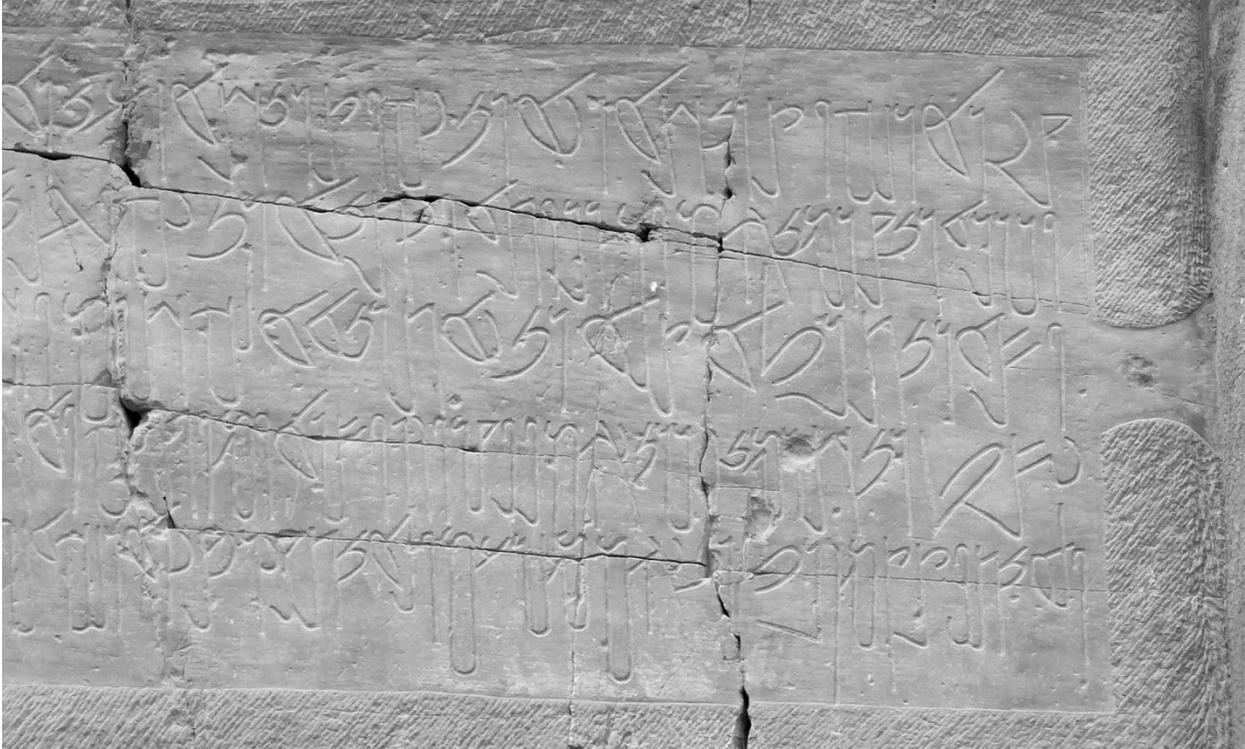
That said, the one element that makes the Turkmanyia unique—the Nabataean inscription—is relatively stable (Figure 6.10). Illustrating the flexibility of CSSI panel designations, the Turkmanyia assessment utilized three separate panels, at different scales, to analyze the stability of inscription. The

Figure 6.10: Section of the Nabataean inscription at the Turkmanyia Tomb. Translations of the inscription reveal a list of social and legal conditions for interment within the tomb. The engraving also represents one of the longest and most in tact Nabataean writings in the region. Photograph by Casey Allen, 2016.

widest assessment, panel 5, encompassed the entire architectural feature on which the inscription is located, including adjacent pillars and design elements. With an average CSSI score of 64.0, this panel is within the *Severe Danger of Erosion* category and rated particularly high in independent fissures, undercutting (both impending and present), and invasive bird activity (e.g. nesting, bird droppings, etc). The next inscription assessment scale, panel 7, incorporated the dressed rectangle housing the inscription and its immediate surroundings—no other pillars or decorative elements beyond the inscription. Scoring lower (CSSI average of 55.3: *Great Danger of Erosion*), this panel excluded the severe decay occurring along the outer edges of the broader feature assessed as part of panel 5. Within this more focused area, CSSI identified the largest risks as independent fissures, inherent rock weakness, undercutting, and abrasion. The final inscription assessment, panel 8, concentrated solely on the small area actually containing writing. Working in a much smaller area than the other feature areas, this panel only scored 38.0 (*Problems that Could Cause Erosion*), with the biggest problems identified as

fissures and stone weakness. The differences in these three scores exemplify the importance of context: the inscription itself may be moderately stable but the ledge on which it is located could cause problems in the future.

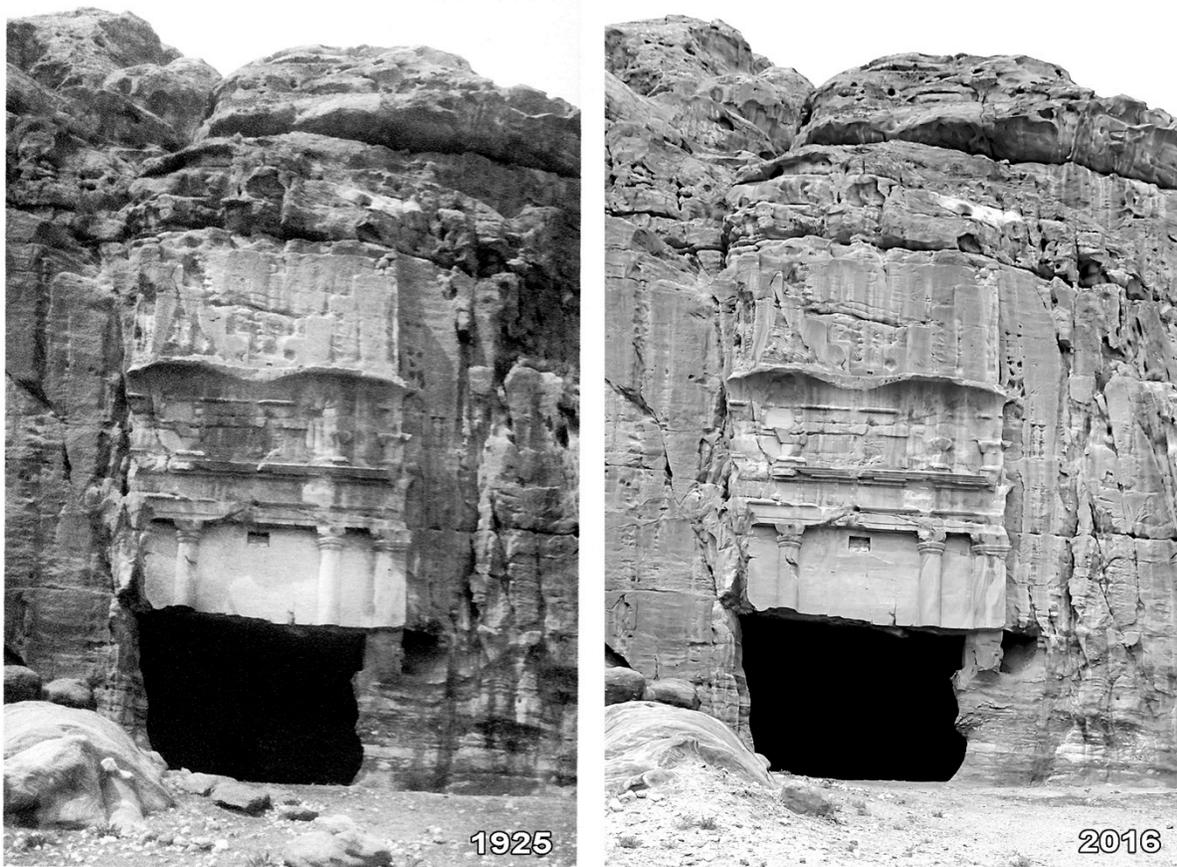
According to the repeat photographic analysis, the Turkmanyia tomb has been in rough shape for some time (Figure 6.11). The tomb's recognizable missing lower half is gone in both images, though it seems some of the rock fall debris has been cleared since the 1925 photograph was taken. Abrasion and streaking from water flow and rain runoff is present in both photos, though it seems to have intensified near the top of the monument between the historic image to the modern repeat. Decay also appears to

*Figure 6.11: Repeat photographs of the Turkmanyia Tomb. 1925 photograph from A. B. W. Kennedy (1925). 2016 photograph by author.*

have advanced on the lower right side of the monument's entrance, where undercutting and flaking has created a small ledge in the modern repeat not present in the historic photograph. Extended beyond the doorframe, other areas of the lower context wall exhibit a greater degree of decay and loss of material

This decay, as well as the clearing of debris, could be explained by other visible changes in the contextual landscape. The sediment and materials ramped against the boulder in the foreground and along the cliff wall at the base of the monument appear to be alluvial deposition, possibly evidence of flood activity. Nested at a nexus of multiple canyons and wadis, Petra is no stranger to flooding (Paradise, 2012). The Turkmanyia Tomb as situated within a wadi of the same name, Wadi Turkmanyia, with a steady enough water supply to sustain a relatively large lemon orchard and other forms of intermittent agriculture. It would be reasonable to assume this wadi has flooded at least once over the past century, possibly causing the observed difference in decay along the base of the cliff and depositional patterns. Alternatively, the rock fall debris could have been salvaged for building material and the boulders in the foreground were extremely friable when touched, making it just as reasonable to assume the differences in visible decay was the result of natural incremental deterioration. Further exploration of the site would be necessary to determine which hypothesis has the most evidence.

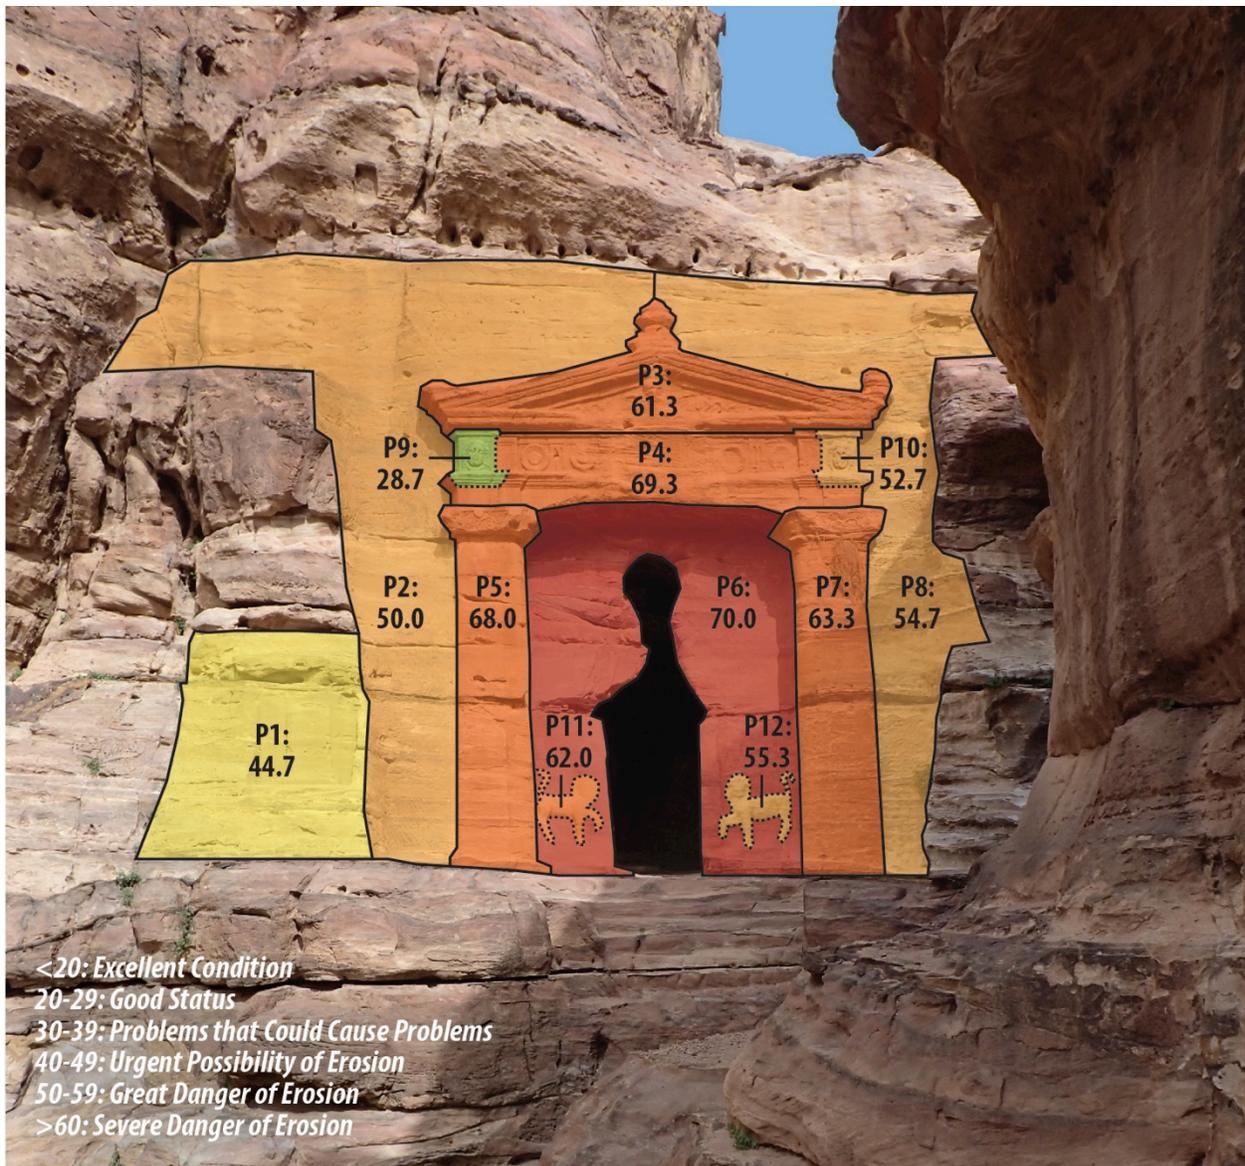
With an average CSSI score of 56.7, the Lion Triclinium was the most stable of the three selected monuments, though it still ranked within the second highest descriptive category, *Great Danger of Erosion* (Figure 6.12). This could be due to a number of factors, possibly including its isolated setting or elevated position within the canyon. Similar to the Turkmanyia, the supplemental panels focusing on specific design elements appeared more stable than the broader panels on which they are located. For example, both carved lions had significantly lower scores (panels 11: 62.0 and 12: 55.3) than their contextual panel (Panel 6: 70.0). With the unique location of the monument and protected surroundings, the majority of concerns identified by CSSI were superficial decay processes mostly centered on loss of detail. Decay processes such as flaking, granular disintegration, and rounding of design features scored particularly high. Large sections of the upper mantels and cornices have been completely smoothed and degraded, making them appear to have melted or dissolved. Advanced flaking, scaling, and crumbly disintegration around the edges of the monument opening serve to support the speculation that the monument once sported a separate door and window. Future loss of detail at this monument is also highlighted in its CSSI scores. Both impending scaling and flaking as well as splintering development are of particular concern. These processes could be exacerbated by tourist activity, as climbing and entering the monument is unimpeded (Figure 6.13).

Figure 6.12: The different CSSI panels and scores for the Lion Triclinium. Colors coordinate with degree of degradation, ranging from green indicating stable conditions to yellow, to orange, to light red, to dark red signifying the highest CSSI scores and most significant decay. Graphic and photograph by author, 2016.

The monument was also not without at least a few structural issues. Most notably were fissures along the bedding plain and textural anomalies. Similar to the Deir, iron rich bands in the substrate have created natural barriers stopping the migration of salts and minerals through the sandstone. With standing water just below the monument and evidence of run off near the façade, along with plant growth on the and near the monument, water seems to play a major role the triclinium's decay—making the

impermeable iron banding all the more impactful. Areas directly adjacent to the banding, for example, exhibit significantly higher rates of splintering, crumbly disintegration, and flaking.

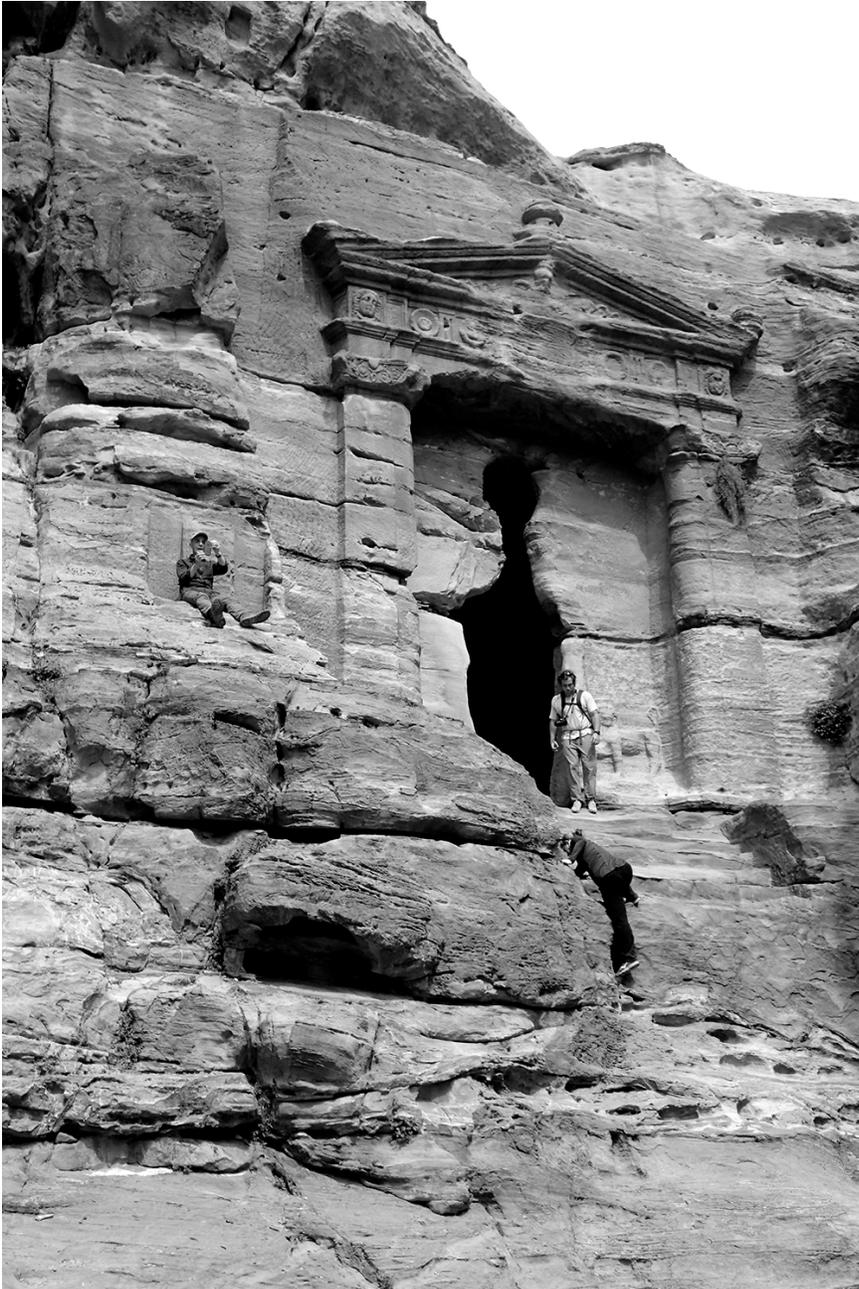
*Figure 6.13: Tourists climbing and sitting on the Lion Triclinium and neighboring shrine indent. The lack of stairs for easy access or signs encouraging or forbidding such activities exacerbates the issue, as tourists only have other tourists' behavior to determine what is appropriate and what is not—which not always correct and can lead to problems (du Cros & McKercher, 2015). Photograph by author, 2016.*

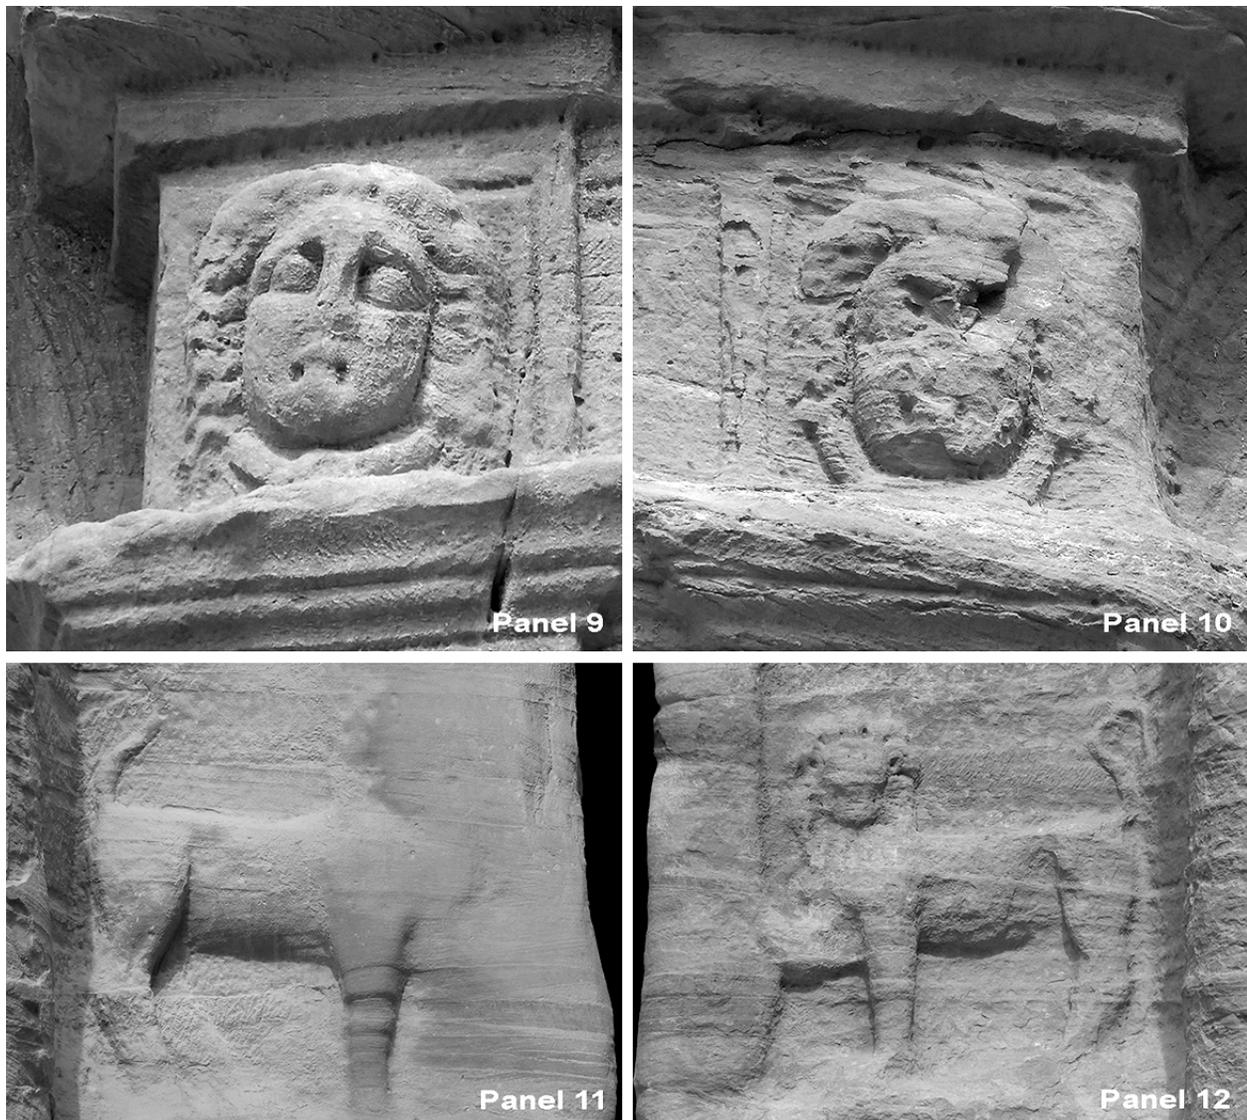
In addition to broader feature assessments, the Lion Triclinium analysis also included four supplemental panels specifically focused on the monument's unique carved elements (Figure 6.14). A few of these features are among the most stable panels on the entire monuments. The lowest scoring

*Figure 6.14: Close up photographs of the carved features on the Lion Triclinium. Demonstrating the flexibility of CSSI panel designation system, these four features on the triclinium were assessed individually as well as part of the surrounding panels. Each panel/feature displayed different decay concerns and stability conditions. Photographs by Casey Allen, 2016.*

panel, panel 9: 28.7 (*Good Status*), is a delicate carved face on the upper left mantel, with the most significant threats being inherent stone weakness and textural anomalies decaying differently. The face on the other side, panel 10: 52.7 (*Great Danger of Erosion*), was not as stable, mainly due to a large missing section of material from scaling and textural issues. Both faces also rated high for granular disintegration, which basically accounts for indistinguishable loss of material/detail and deteriorating stone matrices. When paired with relatively low rock hardness (as is the case for much of Petra), granular

decay can be quite devastating to delicate or detailed stone decoration—making them appear to have been erased or non-existent. For example, large portions of the iconic lions, including the left lion’s face and feet, have blurred almost completely from granular disaggregation. Fortunately, the right lion, panel 12, is in slightly better condition (55.3: *Great Danger of Erosion*), though flaking and salt activities still threaten the feature’s future stability.

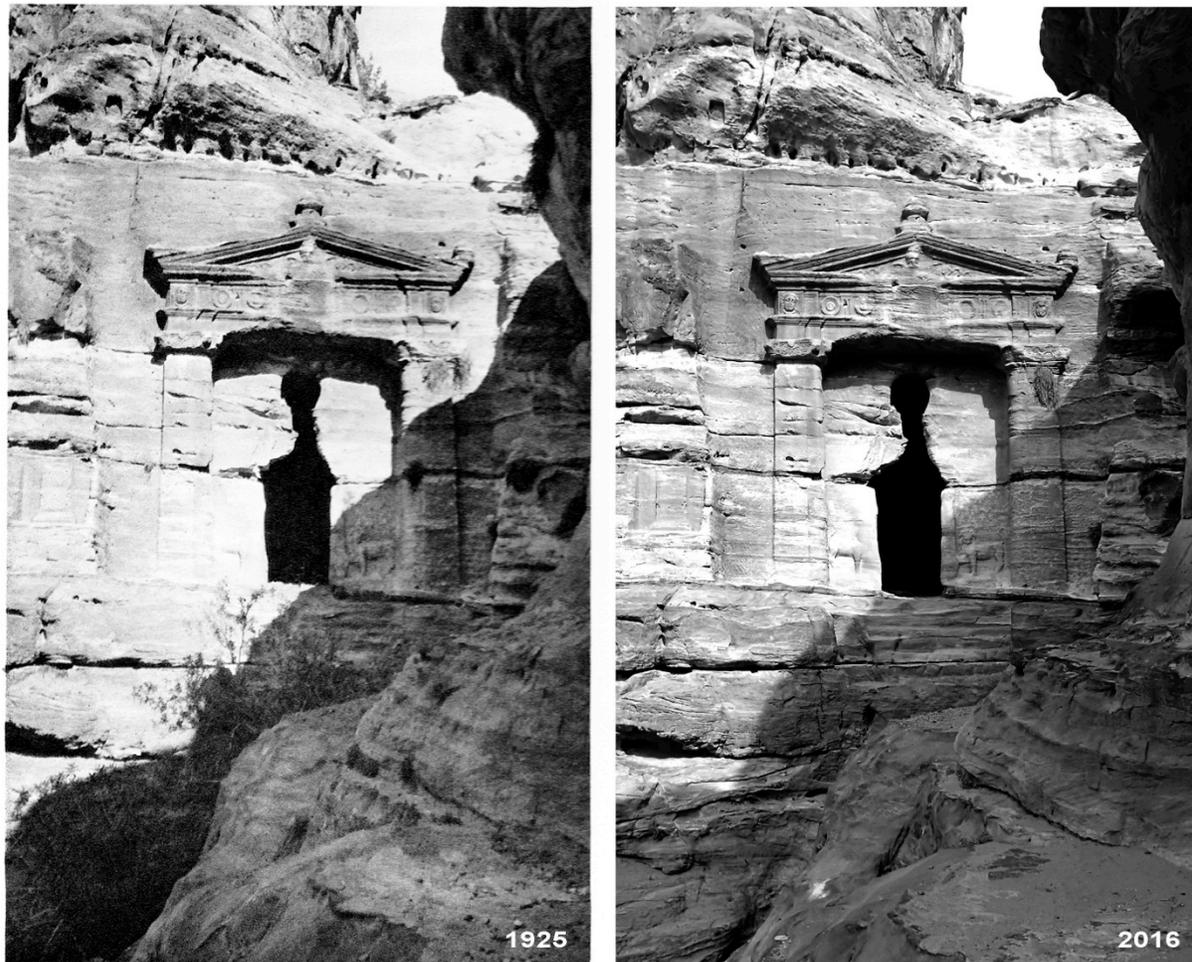
*Figure 6.15: Repeat photographs of the Lion Triclinium. Since the shadow of the adjacent cliff face is so prominent in the historic image, it took three separate visits to the site to correctly replicate the photograph. 1925 photograph is from A. B. W. Kennedy (1925). 2016 photograph is by author.*

vegetation: The tree in the crevice below the façade is gone, the shrub growing in the fissure near the center of the right pillar is not longer there, and the tree along the Monastery trail in the upper background is not longer visible above the canyon opening. The hanging plant in the upper right column has grown, though the second plant behind it have since fallen or been removed. There also appear to be a few small ledges or loose material that have eroded since 1925, especially on the left side of the entrance along the prominent iron banding. The surrounding area also seems to have changed relatively little between the two photographs. The ledge in the foreground exhibits the most significant difference, though this could also be the result of slightly different camera angles or technological distortion.
