## Evaluation of Grenada's "Carib Stones" via the Rock Art Stability Index

While not well-known or well-studied, Grenada's (Caribbean) Carib Stones host over 100 individual petroglyphs (rock engravings) representing some of the Caribbean's best examples. Two sites were assessed for this study: Duquesne Bay along the northwest Caribbean coast and Mt. Rich in the northern tropical rainforest. Their importance notwithstanding, little has been done to manage or assess the Stones other than basic glyph recording. This study employed the Rock Art Stability Index (RASI) to assess and document each panel's overall geologic stability. Using more than three-dozen rock decay elements, RASI represents an efficient and rapid tool to assess petroglyphs and pictographs, assigning an "Excellent -Good-Problems-Urgent Danger-Great Danger-Severe Danger" ranking based on a quantitative score. Overall, 13 panels were assessed individually, with a few exhibiting "Good" status, two in "Great Danger", and the remaining exhibiting "Problems". Analyses show the Duquesne Bay site remains at the behest of its proximity to water, such as stagnating puddles, waves, or storm and household runoff. In contrast, t

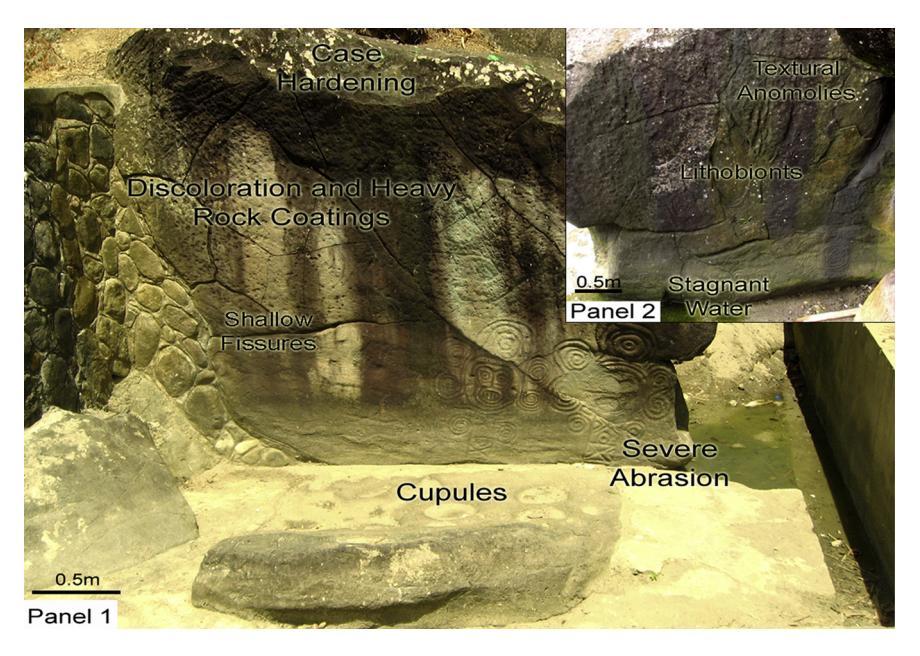
Fig. 3. Duquesne Bay, Panels One and Two. Note the cement (right) and rock-and-mortar (left) retaining walls. While originally erected as a protective measure, they allow storm water and household runoff to collect at the boulder's base, destabilizing it. Note also the extreme discoloration and heavy rock coatings on both panels, including algae and lithobiont coatings.

Representing by far the most well-known, and easiest to find, Panel One depicts what many believe to be male and female humanoid gods (Dubelaar, 1995; Hayward et al., 2009; Marquet, 2009) along with very large, and extremely faint, concentric circles reaching up to six feet in diameter, covering the entire rock face (Fig. 3). The primary concerns with this panel revolve around the amount of stagnant water found around the boulder's base and subsequent significant lithobiont activity and potential for scaling.

Additionally, due to fissures, scaling (spalling) has already occurred on one of the Panel's main engravings, and future scaling is likely to continue in this region, eventually degrading the other main engraving. Dust and particulates trapped in the fissures can expand and contract with wetting and drying, forcing apart grains and eventually larger areas of the rock. In the case of Panel One, because this process is occurring *on* the motifs themselves, it is highly detrimental to the stability. Since the main engravings are near the rock's base, they are in greater danger of being lost.

Despite this intensive surface decay, however, the two humanoid petroglyphs are still very clearly seen, a testament to the incredible depth their creators carved into the rather hard basalt. Yet in light of these findings, Panel One remains in *Great Danger of Erosion*, and will require significant conservation efforts for longterm preservation.

Located on the opposing face of the same boulder as Panel One, Panel Two has similar concerns and is in a slightly worse condition (Fig. 3). The engravings on this section are smaller and closer to ground level, resting in an area where water pools regularly, leading to abrasion events as water recedes. Drainage from nearby homes has also left heavy chemical deposits (efflorescence) on the entire face, raising questions of future abrasion and overall surface stability. Panel Two has also experienced a lot more granular disintegration than Panel One, severely compromising the surface. This could be due to mineral degradation, dissolution due to the efflorescence, or capillary action of evaporites, but also, like Panel One, there are signs of lithobiont pitting. While fissures cover the surface, they are mostly superficial (<a few centimeters deep), posing no structural threat. Given these RASI characteristics, Panel Two was rated as being in Great Danger of Erosion, and requires similar precautions to Panel One.

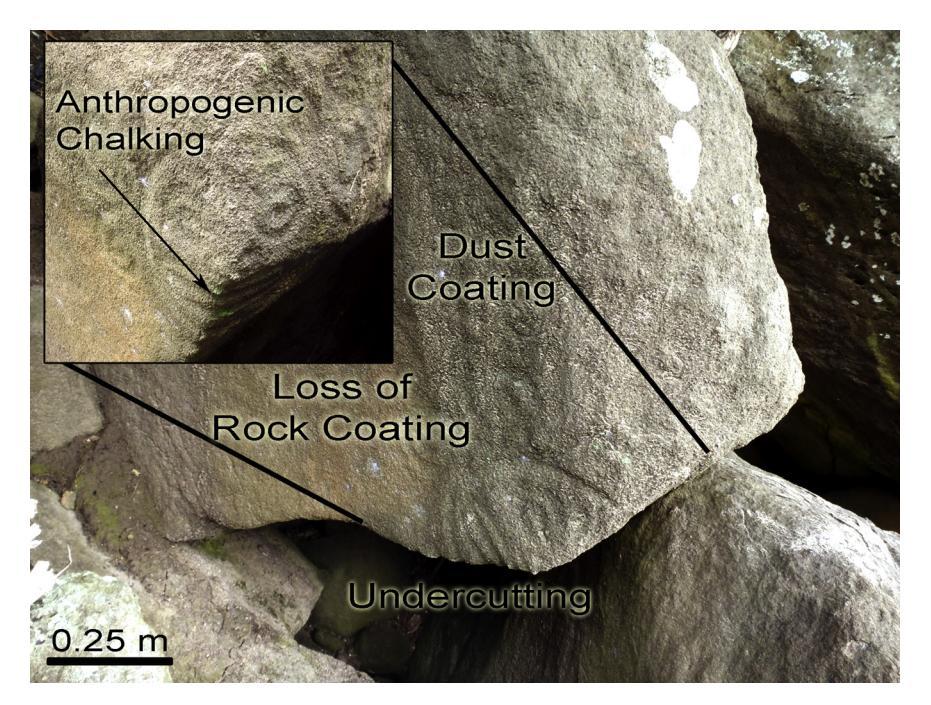
Fig. 4. Duquesne Bay, Panel Three. This boulder fell from the ridgeline long ago, and has rested in its present spot a meter above high tide for many years, according to the local "guides". It is unique as a petroglyph, as the maker used the boulder's corner to create their motif.

Positioned on a boulder that has obviously fallen after the creation of the petroglyph, and found several meters south of the main Panels One and Two, Panel Three, a lone human face, is unique in its carving over two facets: one facing out toward the beach and the other downturned (Fig. 4). The boulder itself remains elevated about a meter above the high tide mark, with the bottom still visible. The underside, with less sun exposure but more water, has developed moss and algae, which could be a concern. The outer face is in better condition, aside from light chemical coatings (from chalking and painting-a common practice among some archeologists to "bring out" a petroglyph's form) and bird droppings. This panel is significantly closer to the sea so there is potential risk of wave damage, particularly underneath, but only during storms. Very thin dust coatings were also observed though, like salts, most likely get washed off after each precipitation event. Unlike the other two panels at this site, however, Panel Three has a thicker rock coating (a layer of hardened minerals that reinforces the surface, see Dorn, 1998) that usually stabilizes petroglyphs (Dorn et al., 2008), helping the panel earn a rating of Good Status despite its precarious position.

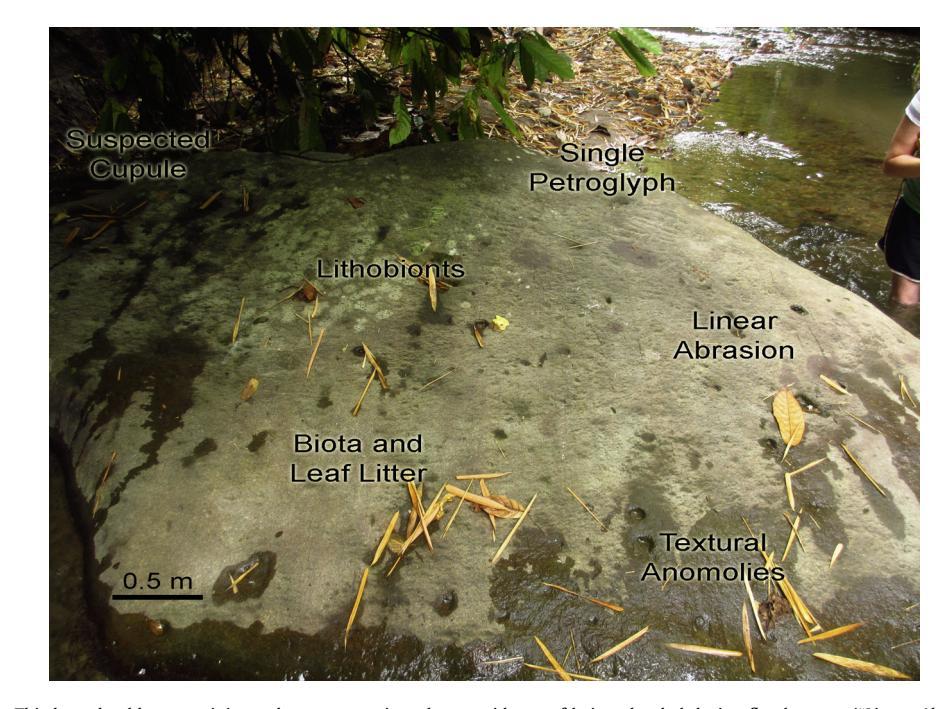
**Fig. 6.** Mt. Rich, Panel One. This large boulder, containing only one engraving, shows evidence of being abraded during flood events ("Linear Abrasion"), as well as significant lithobiont (lichen) growth. Notice also the small cavities ("Textural Anomolies"), potentially from ballistic impact during flood events, and the leaf litter that can secrete chemicals that affect rock stability.

Resting on top of a low-lying flat boulder partially submerged in the stream, Panel One contains a singular face glyph (Fig. 6). On the panel itself, small grooves that parallel stream flow suggest the movement of debris and other objects over the surface during rain and flood events. This causes extreme abrasion and loss of rock coating that, with additional issues stemming from overhanging trees and branches that scratch the panel, destabilizes the rock's surface as a whole. While the glyph itself has been so smoothed it is barely detectable, the panel has a strong stability overall (*Problems That Could Cause Erosion*). Also noted on Panel One is the presence of a suspected cupule adjacent to the petroglyph—though it is not as deep or clear as others found at this site, the distinctive circular pattern can be seen.

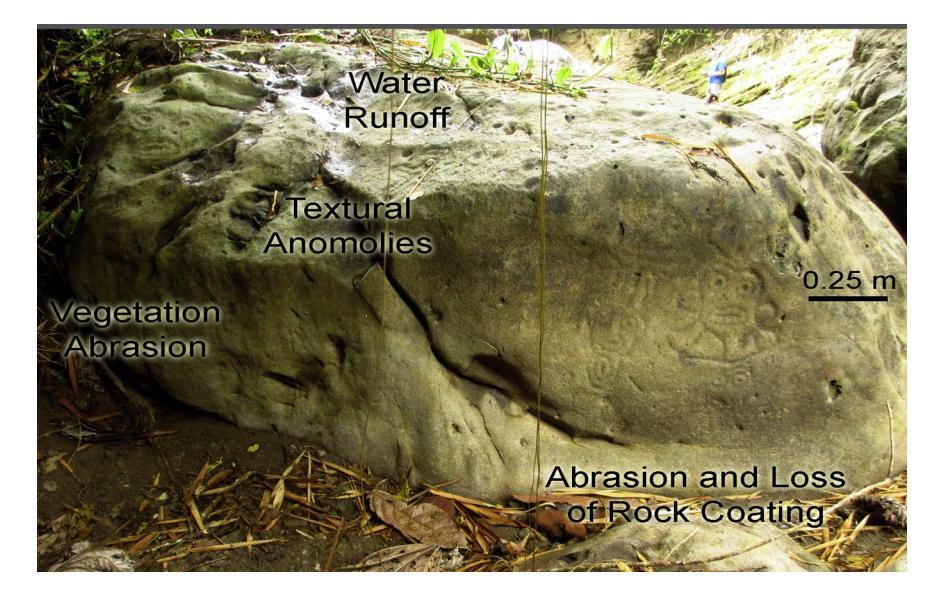
Fig. 7. Mt. Rich, Panels Two and Three. Split essentially in half by a large fissure, the boulder hosting Panels Two (boulder's right-side) and Three (upper left) shows evidence of abrasion from high water events and vegetation, as well as surficial water runoff that comes from the unstable slope (left side).

Consisting of two anthropomorph engravings, Panel Two sits on the downstream edge of the boulder (Fig. 7). There are obvious high water marks where abrasion has removed much of the rock's protective coating, leaving the surface susceptible to other forms of surficial decay and blurring of the petroglyph edges. The petroglyphs, however, are still clearly visible and the panel itself is relatively secure, so it received a lower RASI ranking. Being in considerably better condition than one would suspect for petroglyphs in a streambed (*Problems That Could Cause Erosion*), speculation can be made that the downstream aspect preserves the panel by reducing the risk of impact or other damage during possible flood events, though close proximity to the ravine wall leaves the boulder in danger of being covered by even a small mass-wasting event.

Resting on top of a boulder, Panel Three contains a single anthropomorphic face (Fig. 7). Much like Mt. Rich's Panel One, it has several branches and vines abrading the surface. But a more serious factor is the irregular formation of the rock itself. Dissimilar to the other boulders found at this site, Panel Three is sporadically fractured, uneven, and has fascinating microtopography, including multiple ridges and textural anomalies, that lead to different decay rates that, in this case, remain a major destabilizing agent. The surface stability has been greatly compromised as evinced by the deterioration of the whole rock face due to expansive alveolization (honeycombing) and granular disintegration. The boulder's location next to the ravine wall serves to lessen the risk of flooding, but increases potential loss from soil erosion and landslides. Like Panel Two, Panel Three's petroglyph is within inches of the heavilyvegetated ridge and even a minor mass-wasting event could completely bury the panel. Considering the combination of current decay characteristics with impending deterioration, Panel Three is at a considerably higher risk of destabilizing (Urgent Possibility of Erosion) than its neighbor, Panel Two.

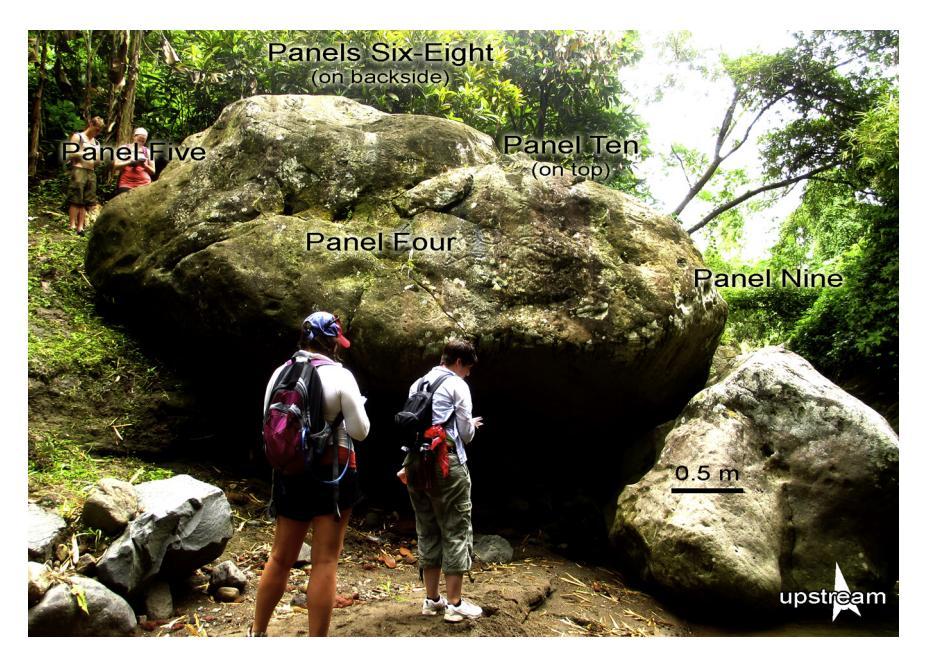
**Fig. 8.** Mt. Rich Panels Four through Ten. This single large boulder contains the majority of petroglyphs at the Mt. Rich site. Note the ubiquitous lithobiont (lichen, moss, and algae) cover, indicating a perpetually stable and moist state. Panel Four contains the largest fissure of the boulder's fissures which bisects Panel Ten (top) and separates Panels Seven and Eight (backside of boulder). The small rock in the lower-left corner offers evidence that this boulder slid down the slope, rather than tumble, as petroglyphs from Panel Eight abut against it, making it impossible to create the engraving *in situ* (see Fig. 9).

Upper Four contains the majority of the panels' fissures, with several running the entire panel length. Surficial water runoff, undercutting, and a large textural anomaly along the main fissure, also raise concerns about Upper Four's structural integrity. Some textural anomalies have also lead to slight differential and cavernous decay, which only encourage the habitation of small organisms in the cracks, increasing stresses on the rock. With these elements then, Panel Lower Four, with the majority of lithobionts, is in significantly more danger of erosion, while Upper Four displays problems leading to erosion. The disparity could be due to the lower half's closer proximity to the point of impact and/or greater flood damage and higher humidity rates being closer to the water source, though averaging the two panels' scores results in an *Urgent Possibility of Erosion* classification (Fig. 8).

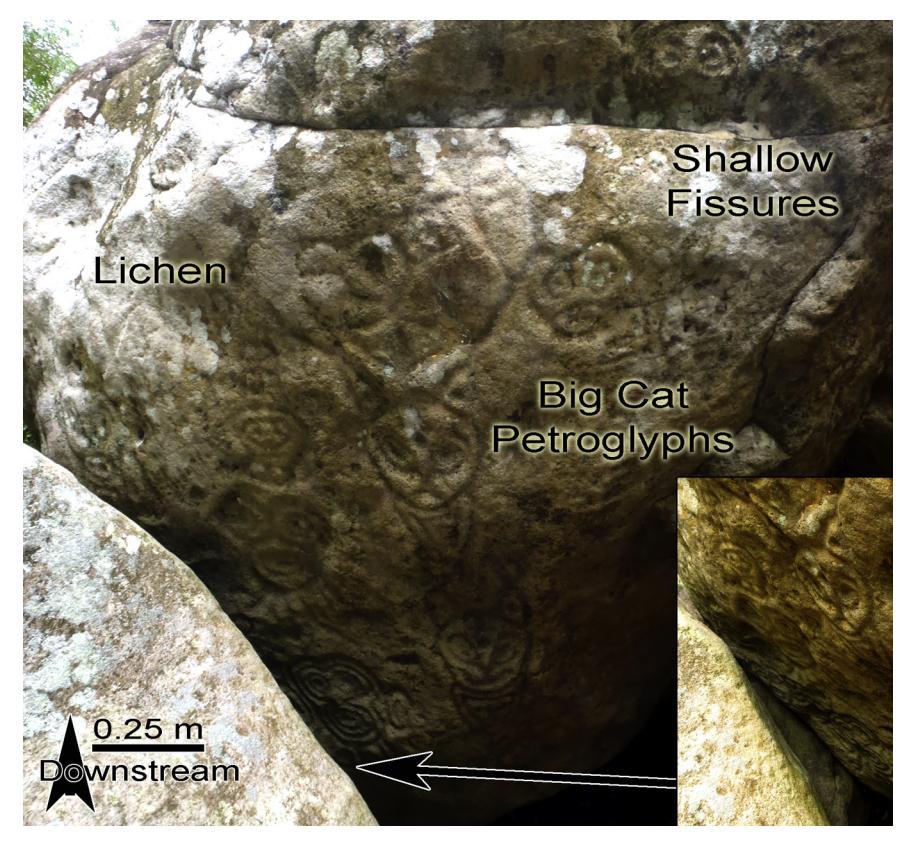
Fig. 9. The "Big Cat" petroglyphs at Mt. Rich, Panel Eight. Unique among West Indian rock art, these "remembrance" etchings remain fairly stable from a rock decay standpoint. The inset image shows the impossible carving angle, supporting the notion that the large boulder came to rest against the smaller boulder during its presumed sliding down from the ravine's top.

With a high concentration of heavily pecked petroglyphs representing an array of subjects, Panel Eight on the underside of the south aspect, contains particularly interesting glyphs: several large cat-like engravings (Fig. 9). What makes these zoomorphics so intriguing is the absolute absence of any large mammal-including any feline species except domestic cats first introduced during the Colonial Period-on the island. The largest mammal to inhabit Grenada is the >1 m in size Mona monkey, introduced (accidentally) in the early Colonial Period via a slave ship. Based on similar South American motifs (Whitley, 2001), this leads to the assertion that these particular petroglyphs serve as a type of "remembrance" from a previous location, most likely from Venezuela, based on the size and shape (David S. Whitley, W & S Consultants, 25 May 2012, e-mail). This hypothesis is further supported with archeological evidence that the Arawak and Carib Indians (the presumed "authors" of the Carib Stones) migrated from northern South America where large feline species are common (Hayward et al., 2009).

Considering the age, location, and mass-wasting event the entire boulder experienced, this panel is in remarkably good condition, especially for being in the direct flow of water during floods. The rock coating has long since eroded and there is a fairly large fissure running down the side, but the engravings are so deep, they remain incredibly clear. Much like the rest of the boulder, Panel Eight contains copious lithobiont pitting, but again, this is mainly confined to the surface, and does not yet threaten the deep carvings. Overall, this unique panel is experiencing *Problems That Could Cause Erosion*—a very good score for a panel resting in and near a stream for such a long time.
